COMMERCIAL BUILDING SURVEY

Morden

Surrey. SM4 XXX

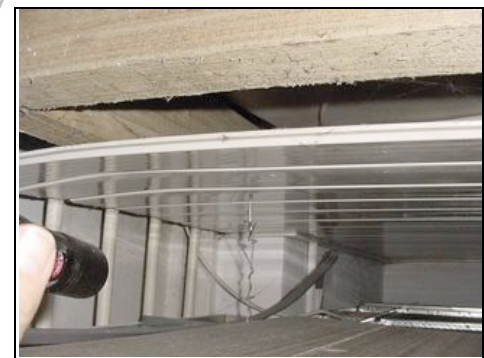
Looking above the suspended ceiling there is a secondary ceiling with a plastic cladding. We believe there is a concrete ceiling above this.

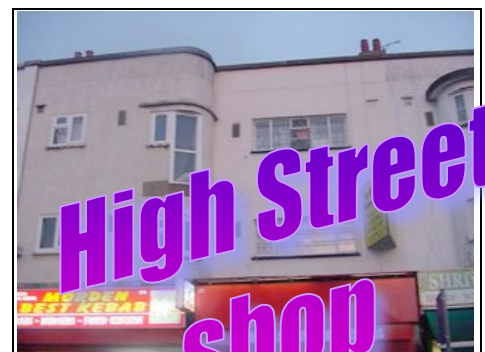
Whilst we could not see any obvious signs of problems we have dealt with these properties before where there has been issues with leaking showers and washing machines from the residential property above which has impacted the business below.

Residential area above retail unit

ACTION REQUIRED: Your Legal Advisor to contact the Management Company to establish if there have been any such problems.

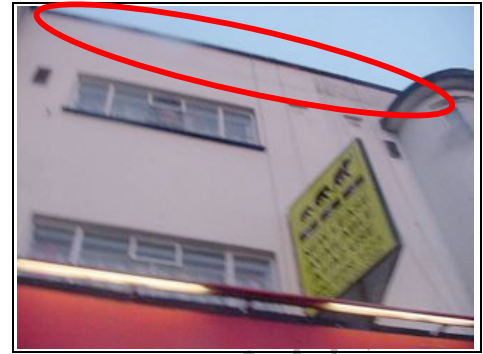
We have no way of establishing the condition of the roof without opening up the roof.

We have not viewed the roof

We would not recommend committing to legally purchase the property until the roof is inspected.

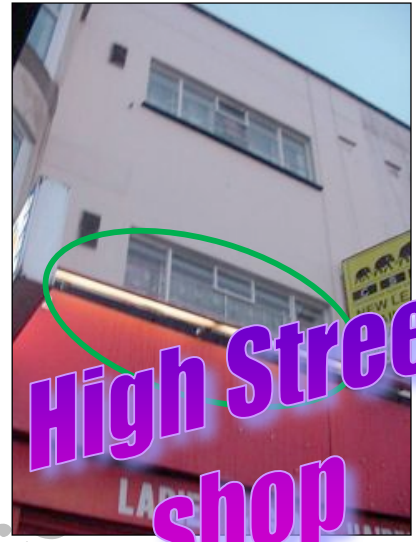
We have not had access to view the roof due to its height and no one being in the flat that overlooks the roof at the time of our survey.

Hidden flat roof at front of property

ACTION REQUIRED: We would be happy to return to view the roof assuming that access can be gained which we would recommend is carried out via the first floor flat (no one was in when we knocked at the time of our inspection).

We would not recommend committing to legally purchase the property until the roof is inspected.

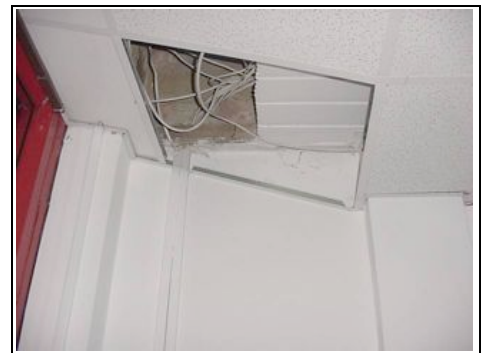
Opening in ceiling with sign of front flat roof leaking

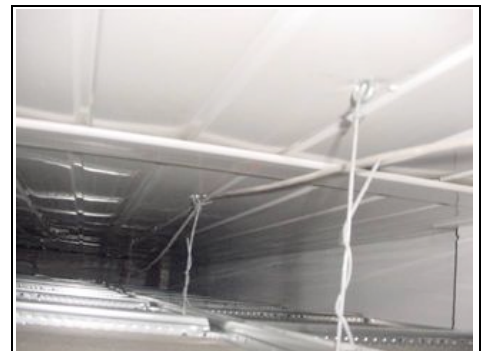
We believe there are problems relating to corrosion of reinforcement within this type of non traditional construction. Unfortunately due the way the property has been constructed and alterations added after the structure of the property is hidden from us.

Plastic cladding above suspended ceiling 16

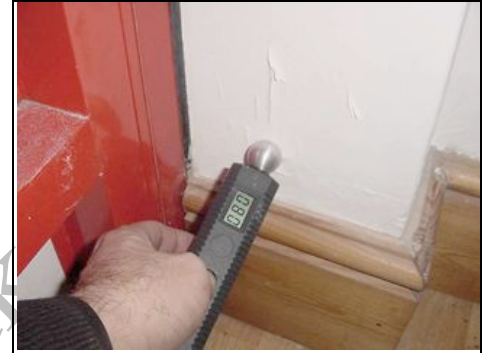
We have found dampness at double the levels we would expect to find in this type of construction particularly to the left side of the property.

Damp front left reading 80

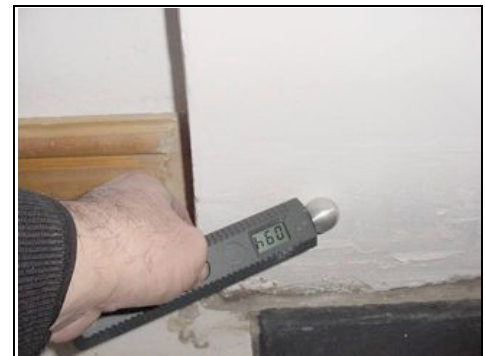
Damp middle left side reading 94

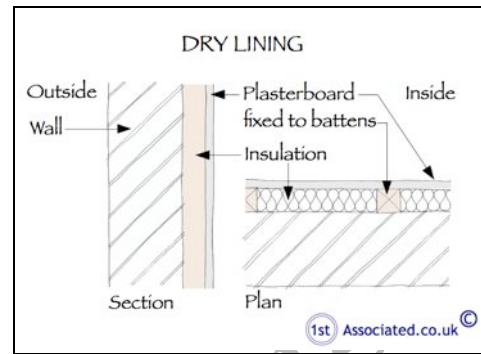
Dry lining

ANTICIPATED COST: To dry line property throughout £1,000 to £3,000 dependent upon the standard; please obtain quotations.

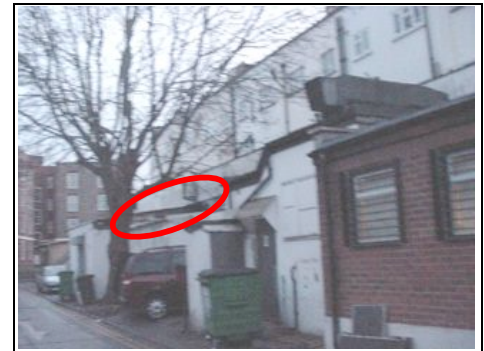
Rear conservatory roof

Problems we can see are the shallowness of the pitch which is below what we would typically expect to see which means that rainwater does not discharge off the roof very readily. In addition to this you have leaves and branches landing on the roof from the adjacent tree literally next to the property. In a best case scenario the

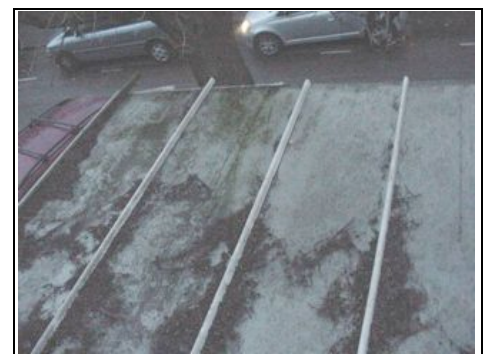
Leaves and branches on polycarbonate roof

leaves and branches will block the roof from discharging rainwater and ultimately lead to roof leaks. In a worst case scenario you may have a branch come through the roof.

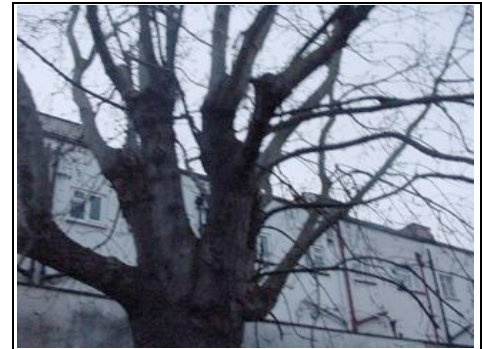
The large tree via falling branches etc cause impact damage. We noted a fairly large quantity of leaves on the shallow polycarbonate roof at the time of our inspection which do need to be cleaned away regularly to stop the roof from deflecting and letting in rainwater/failing.

Large tree to rear of property

ACTION REQUIRED: We would recommend an arboriculturalist (not a tree surgeon) is asked to give advice

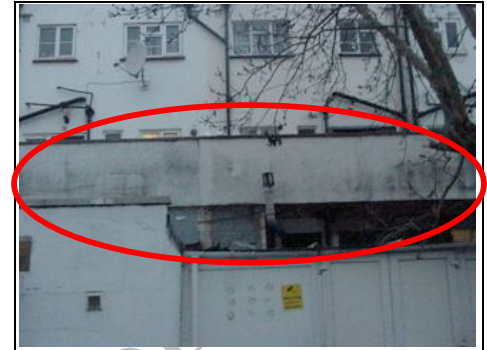
The rear walkway which is directly above part of the retail unit has an asphalt covering and is looking the worst for wear. In addition to the wear to the asphalt there is a general undulation in the roof indicating that deterioration is occurring.

Walkway to rear of property

It is relatively common for this type of walkway to leak.

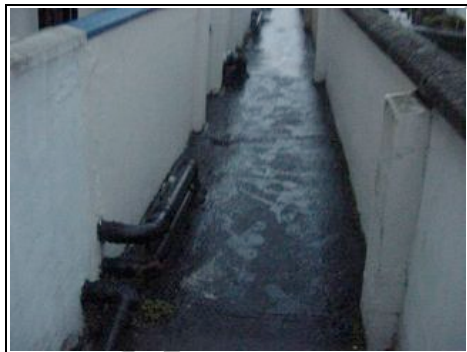
Walkway in poor condition

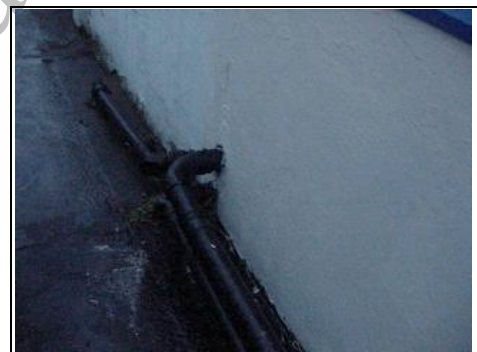
Walkway deteriorating

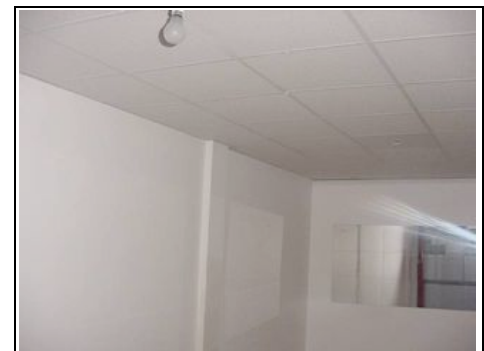
We note that there are several ceiling systems in place which to us indicates there are problems with dampness/condensation coming through from the floor above/condensation which is as mentioned a characteristic of this age, type and style of property.

Suspended ceiling system

ACTION REQUIRED: Your Legal Advisor to check and confirm any roof issues.

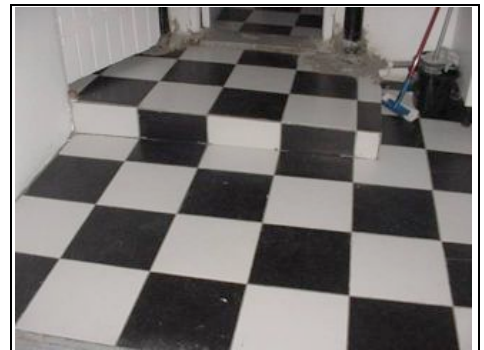
The conservatory area has a poor quality suspended timber floor made out of chipboard or similar. We would expect to find wet rot beneath the floor and it will only be a matter of time before the floor will require replacement.

Conservatory area floor

ACTION REQUIRED: Open up the floor to inspect. We would fully expect that the floor will require replacement in the not too distant future.

ANTICIPATED COST: In the region of £2,000 to £10,000 dependent upon what is found

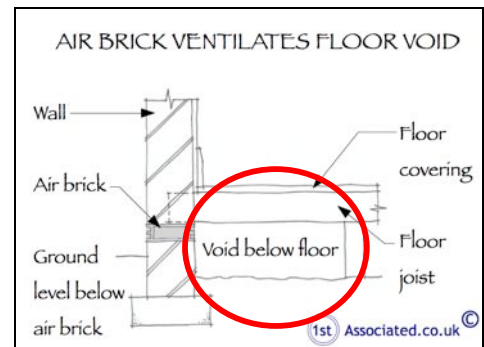
Suspended timber floor 21

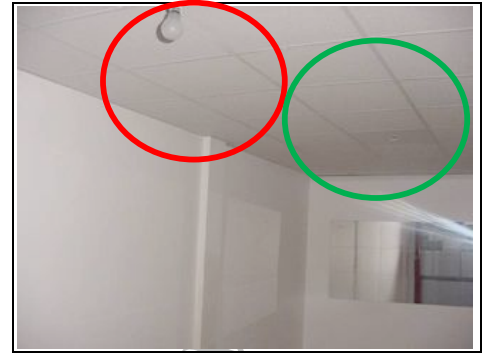
It probably goes without saying that a general modernisation is required from anything from modern Category II lighting within the retail unit to upgrading of the WC, kitchen and conservatory areas.

Light bulb (red circle)
Hole in ceiling tile (green circle)
where traditional lights rather than Category II commercial quality lights

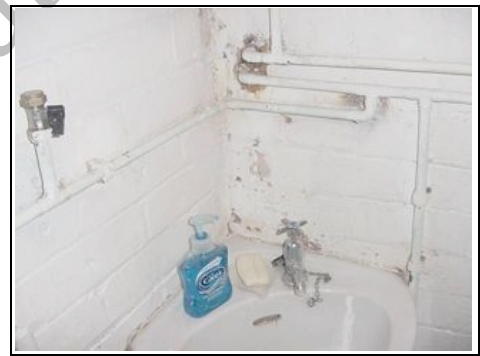
Sink requires repair

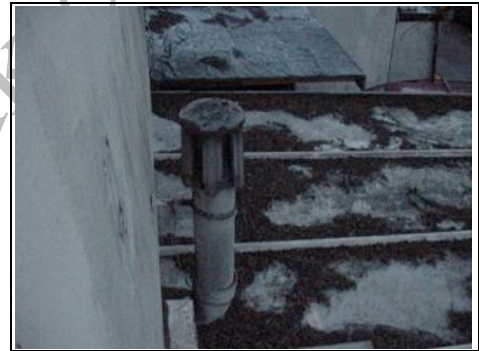
We always have to give a warning of possible asbestos as when this building was being built asbestos although was no longer in use as in larger quantities as was once used it still was being used for some elements.

Asbestos flue

Our insurance company require us to advise we are not asbestos specialists. We recommend you have an asbestos survey carried out by a specialist asbestos company.

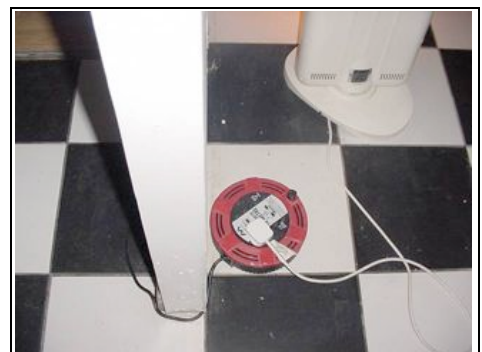
There is a lack of electric points particularly for example around the kitchen area. We also noted extension cables etc were being used in other areas.

Extension cable

ACTION REQUIRED:
Upgrade required.

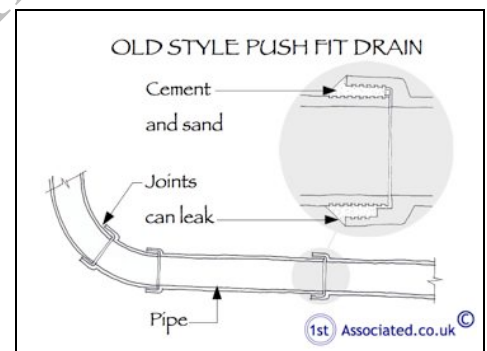
We would recommend a closed circuit TV camera report. In older properties, such as this, drainage was often push fitted together rather than bonded together.

Push fit drains

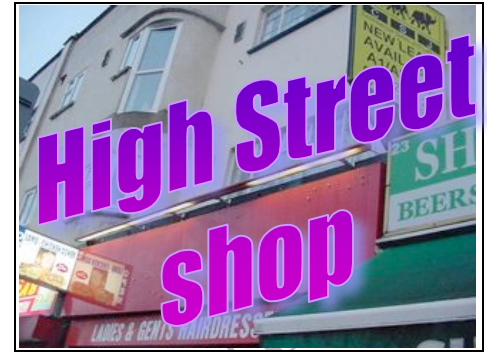
We would be more than happy to return if access can be gained from the occupiers above to view this roof. We would not commit to purchase before this roof is inspected as internally there looks to be water leaks coming from above.

Front hidden flat roof

ACTION REQUIRED: Please see our comments in the Executive Summary.

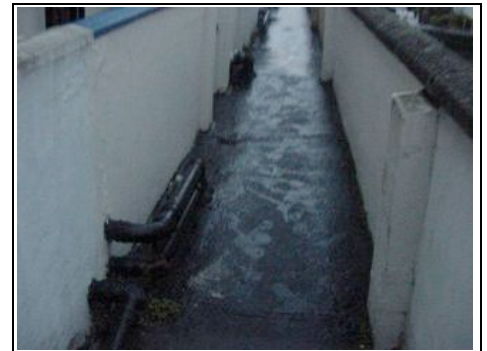
The rear walkway is asphalt covered and in a below average condition.

Walkway

ACTION REQUIRED: Please see our comments in the Executive Summary.

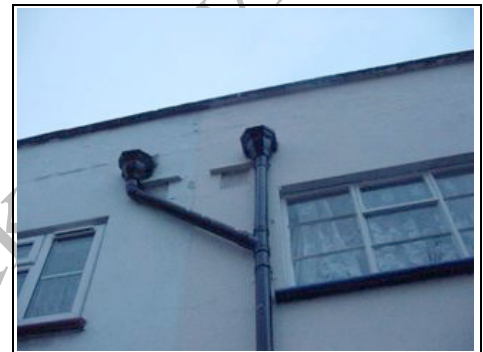
Hopperheads and downpipes

ACTION REQUIRED: We would always recommend that the gutters and downpipes are cleaned out, the joints are checked and the alignment checked to ensure that the gutters fall towards the downpipes.

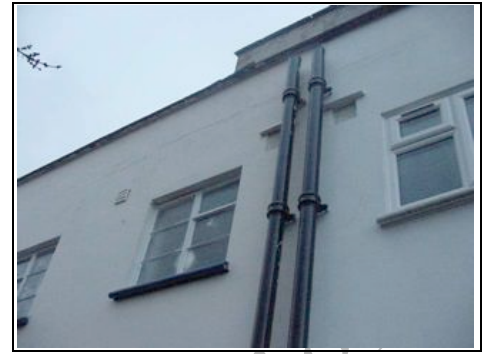
The property has cast iron soil and vent pipes the property. We can see where the soil and vent pipes travel from the floor to the rear. Cast iron of this age will need regular maintenance or repair.

Soil and vent pipe to rear

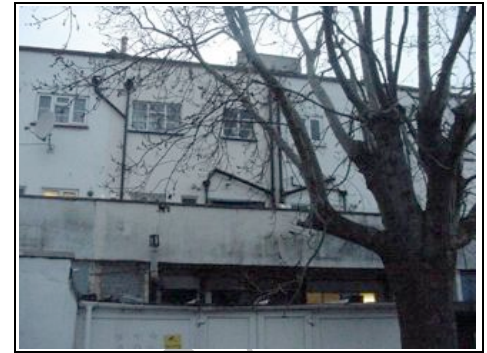
There is a large tree within what insurance companies would term as influencing distance of the property

Tree to the rear of the property

ACTION REQUIRED: We would recommend an arboriculturalist (not a tree surgeon) is asked to view the property and give a ten year plan for maintenance.

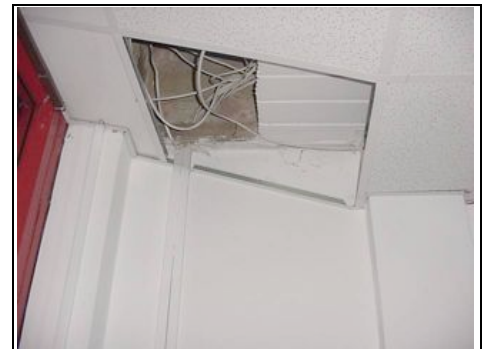
Opening in ceiling – flat roof leaking

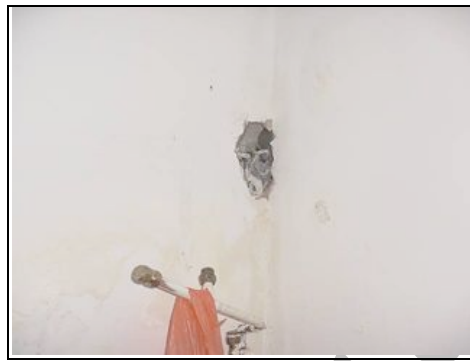
There are holes in the toilet area which require repair and redecoration.

Hole in ceiling in toilet

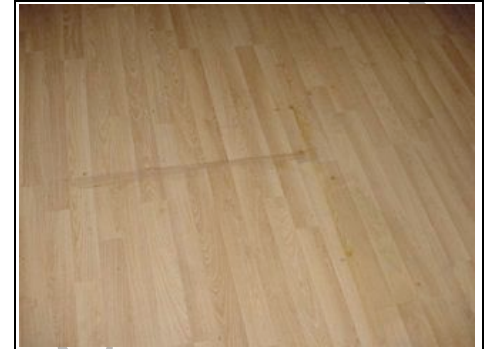
Marks to laminate shop floor

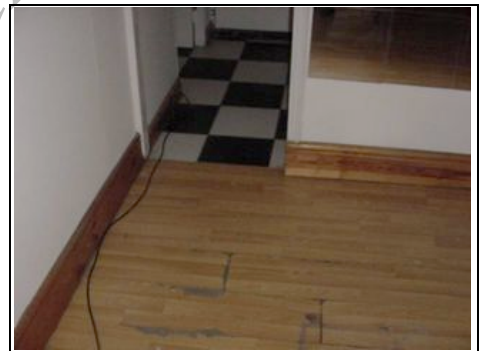
Worn floor to rear

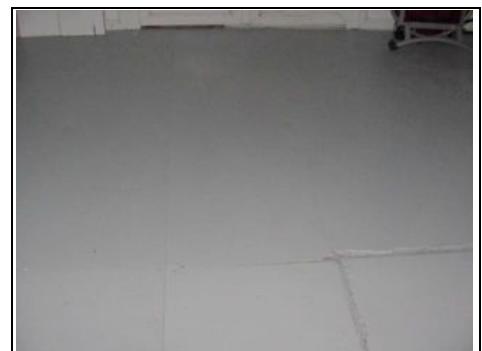
To the rear of the property there is a DIY quality suspended timber floor to the conservatory area which is unusual and likely to have wet rot underneath this area.

DIY quality timber floor

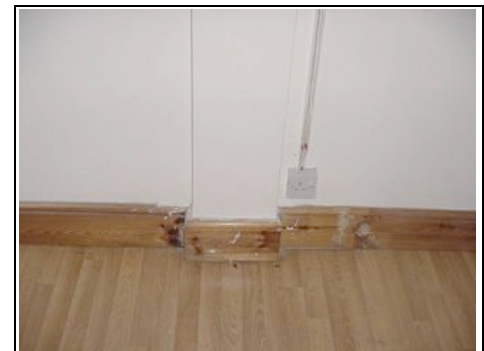
A random visual inspection and tests with a moisture meter have been taken to the perimeter walls. In this particular case we have found dampness. We would comment as follows that we found damp readings to the left side (all directions given as you face the property from the front) higher than we would typically expect to find.

Damp to left side of property

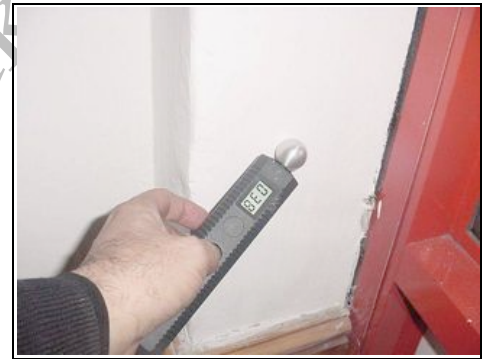
We used a damp meter on the external walls. We have found dampness. We found it to be above what we would expect for this age, type and style of property.

Testing for lateral dampness

ACTION REQUIRED: Please see our comments in the Executive Summary.

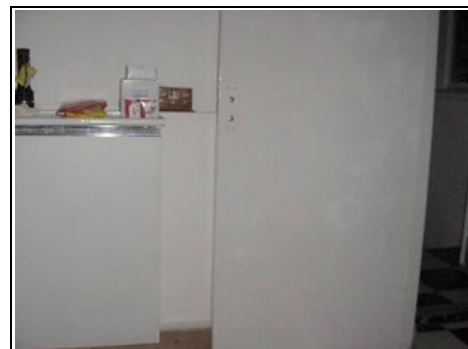
Door to office requires ironmongery

ACTION REQUIRED: Replace ironmongery.
