# PROPERTY REPORT

**XXXX**  
**Islington,**  
**London. N1 XXX**

We have been instructed to inspect and prepare a Report and Schedule of Condition for XXX Islington, London. N1 XXX

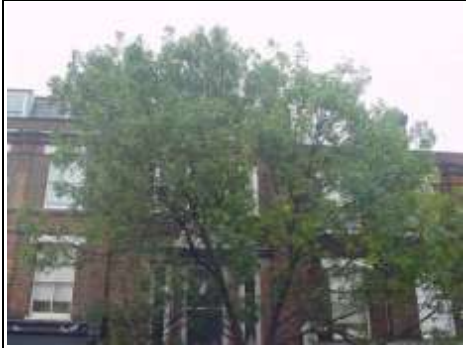
Top of front elevation obscured by tree

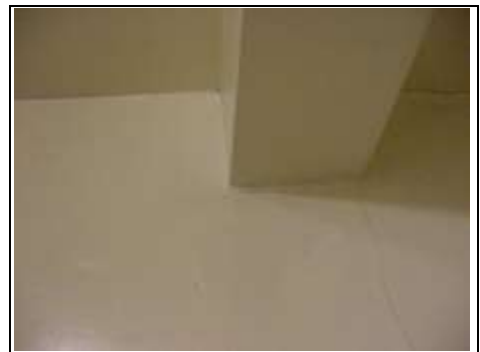
We could see cracks within the building that look to be structural and therefore recommend that anything relating to movement in the property is excluded from the lease. The cause of the movement is likely to be, in our experience, leaking drains.

Cracking around spin beam in store

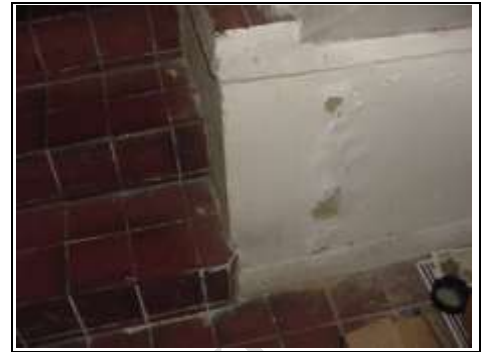
There is dampness coming up through both the floors and the walls we believe that this is in part to do with the drains blockages that we can see and partly to do with the underground drainage leaking.

Internal dampness at basement level

Dampness needs to be excluded from the lease as we do not feel you should be responsible for this problem.

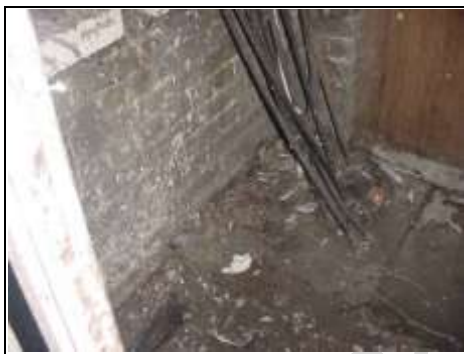
Drainage rods stored to rear are always good indicators that the drains block a lot

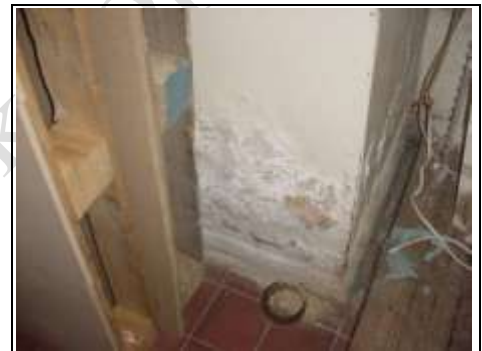
Dampness

We would add that some of the dampness is self inflicted and some of the worse that we have seen for many years. At the time of the survey when we ran the taps for only a few minutes and the rear of the property flooded. The owners were very concerned about us running the taps due to the water meter, we feel it was due to the major problems they have with the drainage system.

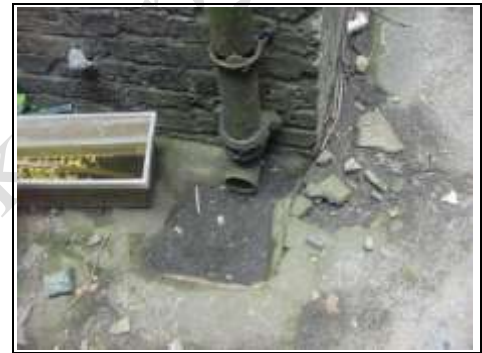
Blocked drain

**ACTION REQUIRED:** We would recommend that the drains are unblocked prior to you committing to complete on this property and also closed circuit TV camera report (sorry to repeat ourselves but this is very important) of the drains to be carried out to give you an indication of the problems. At the moment you have got sewage literally discharging into the yard at the rear of the property. Problems will be increased when it rains.

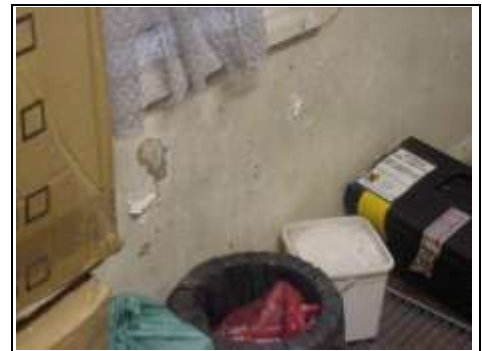
Dampness in store room

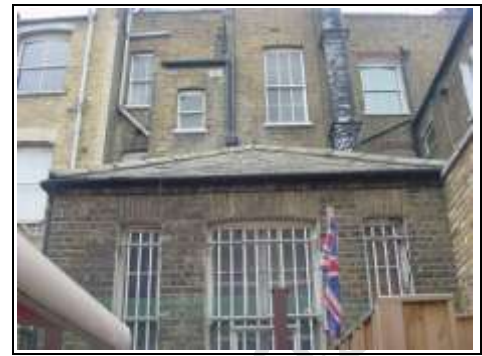
We can see that the slate roof is deteriorating and it is likely that the nail fixings are rusting. Whilst this may be a shared responsibility it will have a direct impact on your property as it is over the kitchen area (unfortunately we could not see any way of getting access into the kitchen roof space).

Kitchen roof from outside directly onto the nursery

**ACTION REQUIRED:** Exclude from the lease and/or the existing owner to repair the roof and then you take on the responsibility.

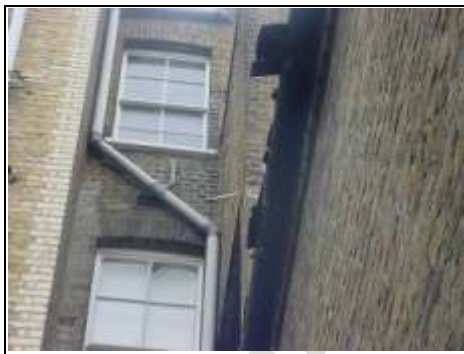
Slates hanging off

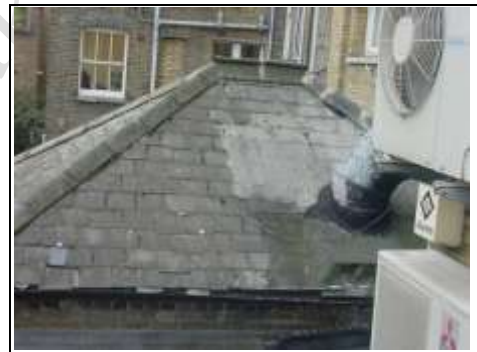
Felt repairs and lead tingles holding the slate on

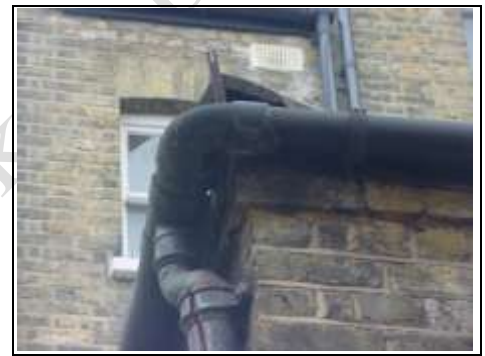
There is a mixture of cast iron and plastic gutters and downpipes. We could see that the cast iron is cracked and also has holes in it meaning that any rainwater is not collected in the pipes but is discharged onto the basement area walls below which, in turn, causes dampness to get into the property.

Plastic gutter and cast iron downpipe cracked

Repair/replace the gutters and downpipes and ensure that they are discharging the rainwater away from the roof.

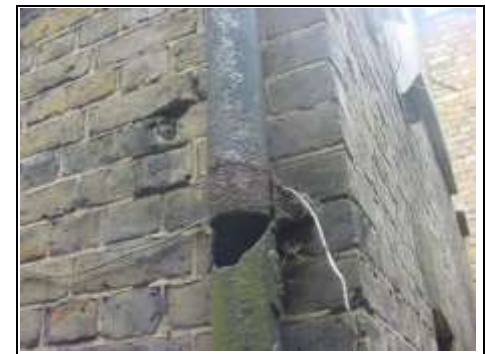
Broken downpipe

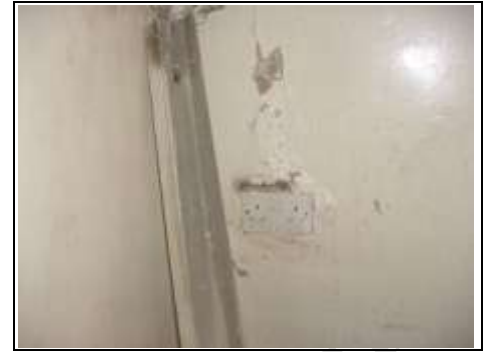
As mentioned the property has dampness coming in through the walls and the floor which will mean that your storage facility will not meet Environmental Health Standards unless work is carried out.

Lateral dampness on party wall

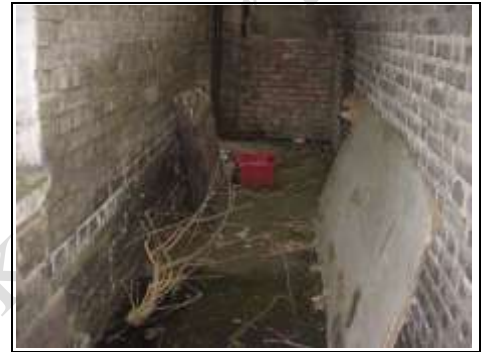
Flooding to rear property when taps had been run due to blocked drain in passage way

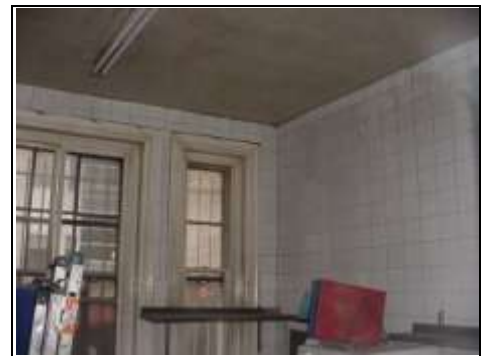
In addition the property would not meet Environmental Health Standards due to not having a smooth impervious surface and there are general ingrained dirty areas where you will need to give the surfaces a thorough clean before you carry out any redecoration.

Ingrained dirt to tiles

**ACTION REQUIRED:** We would recommend an informal meeting with Environmental Health prior to committing to purchase the lease on these premises and to walk them around to get a general feel for what they would require to be carried out.

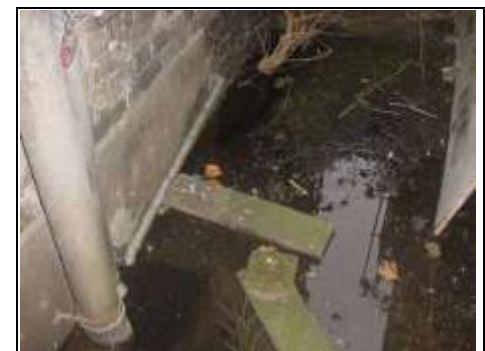
Flooding to passage way when taps had been run

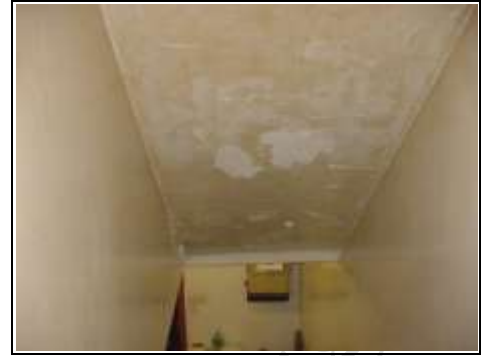
Generally throughout the property, as you are aware, the decoration standard is poor and requires redecoration however this will be difficult with damp walls particularly from what we can see it will be very difficult in the short term to get rid of this dampness.

Ceiling requiring redecoration

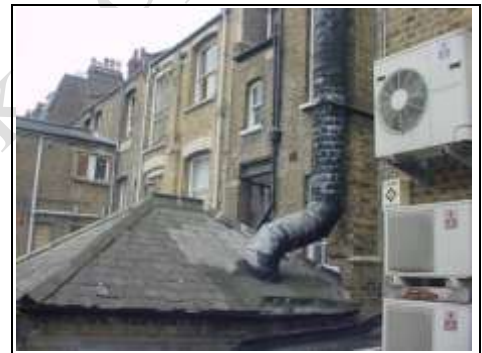
The extract system that is in place we cannot see any way of cleaning it via access points although we have not been able to gain close access to it.

Extract flue not possible to clean hatches to these to allow

We have, in the past, added access hatches to these to allow examination.

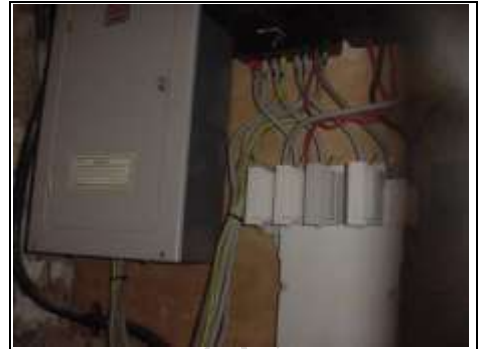
Given the general condition throughout the property we would recommend an Institute of Electrical Engineers (IEE) test and report on the property particularly as you are likely to be using far more electricity than has been used in the property for awhile.

Old electrics

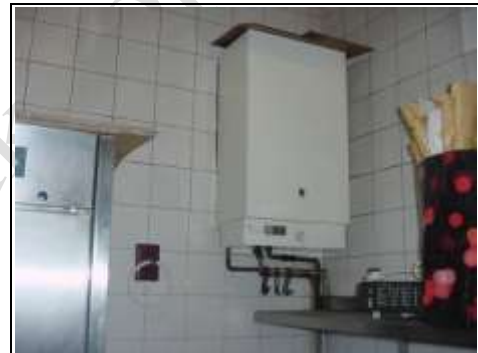
Boiler in kitchen

The boiler that we have seen within the kitchen does not seem to be legal. You need to have a Gas Safety heating engineer check this. We would recommend that the system be tested and overhauled before exchange of contracts and that a regular maintenance contract be placed with an approved heating engineer.

**ACTION REQUIRED:** A Gas Safe report to be carried out, you may have to relocate the boiler.

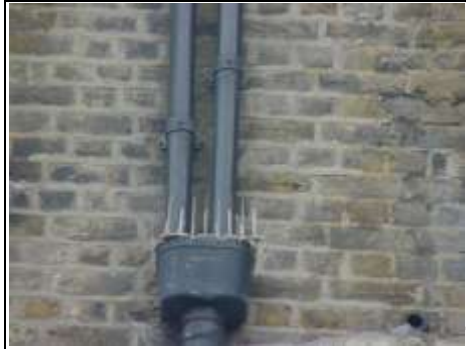
To the rear the gutters and downpipes have pigeon defectors to stop pigeons from landing. From the sheer number of these there looks to have been a big problem with pigeons. There were not any pigeons at the time of the survey (other than the dead ones in the rear yard).

Pigeon problem to rear

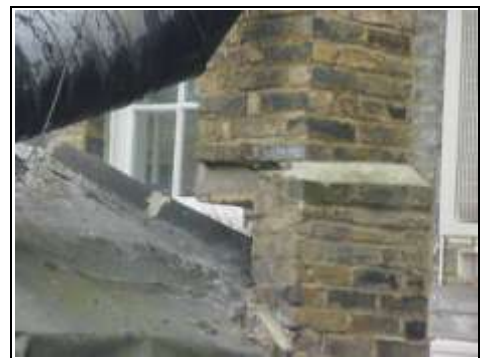
Amendment to chimney

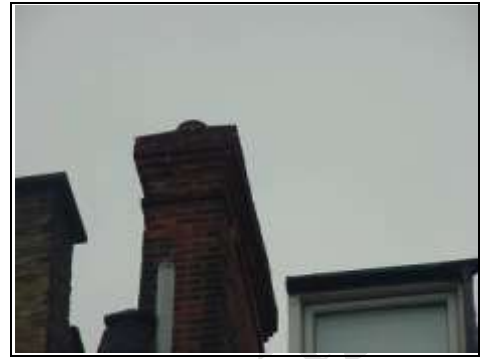
Chimney Two

This chimney is brick built in a soft red brick, these chimneys tend to deteriorate and require re-pointing. We have not had access to the upper part of this property so we cannot comment upon whether any dampness is getting in however this is often the case.

**ACTION REQUIRED:** As mentioned in the Executive Summary you need to establish your maintenance liability.

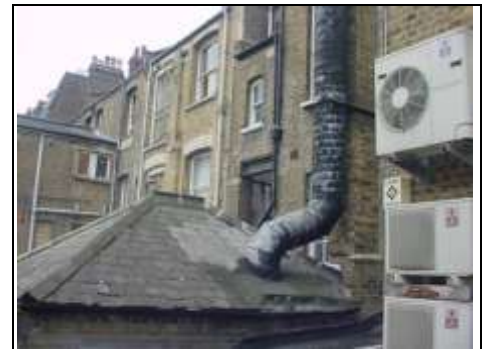
The property has a large metal as mentioned in the Executive Summary there does not appear to be a way to readily access this or clean it. We can see that it has been tarred in the past indicating to us that it has leaked and we can also see there are repairs to the base of the flue around the roof indicating that water has leaked through as well.

Extract flue

**ACTION REQUIRED:** Work will be needed to this flue, we would set aside the sum of £5000 (five thousand pounds) in case it needs replacing in part.

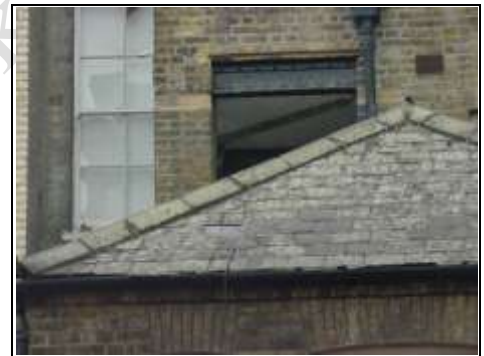
The rear roof located over the top of the kitchen area is pitched and clad with a slate and, from ground level, this looks in poor condition considering the roofs age type and style which will have a direct affect on your business if and when it leaks. Also as it discharges via the defective gutters and downpipes water down the outside of the property this leads to lateral dampness.

Low level rear roof

**ACTION REQUIRED:** The entire roof requires an overhaul and improvement together with the associated gutters.

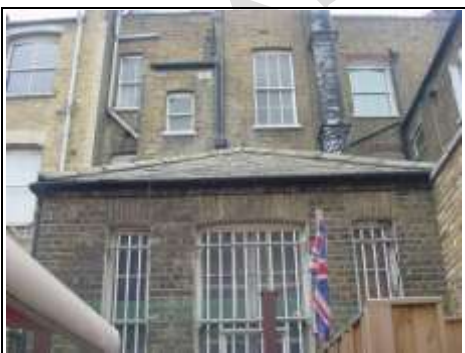
Kitchen roof disperses rainwater directly onto nursery

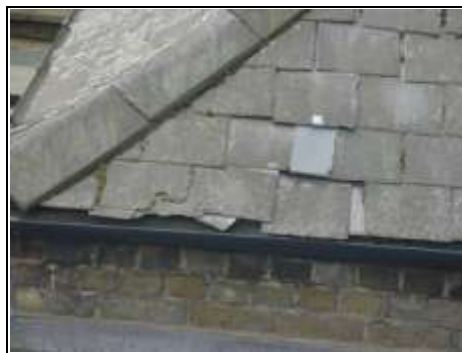
Close up of miss placed and broken slates

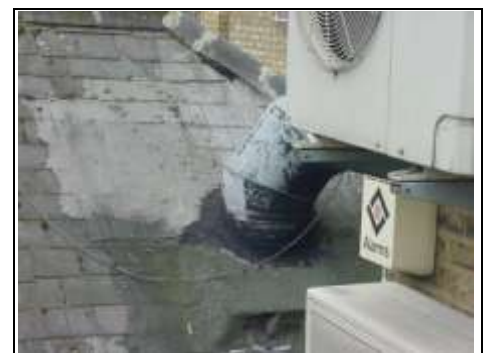
Felt patch coming away

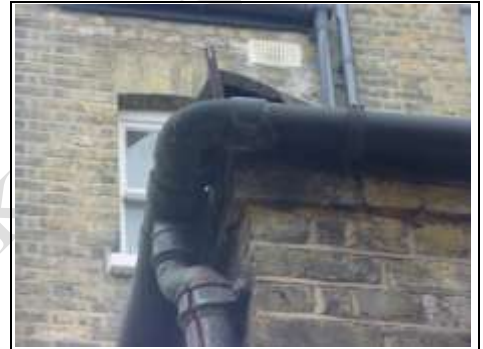
The property has a mixture of the original cast iron gutters and downpipes and plastic. Please see our comments in the Executive Summary as they are in poor condition.

Plastic gutter and cast iron downpipe which is cracked

**ACTION REQUIRED:** Replacement and renewal. We would always recommend that the gutters and downpipes are cleaned out, the joints are checked and the alignment checked to ensure that the gutters fall towards the downpipes.

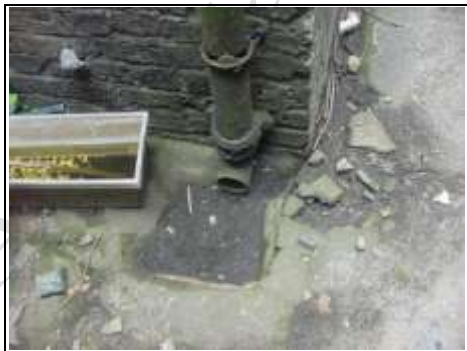
Blocked drain

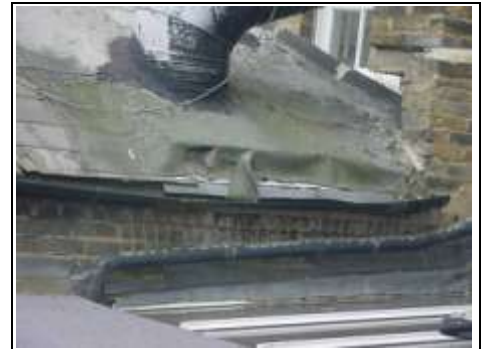
Gutter is discharging onto next door's roof

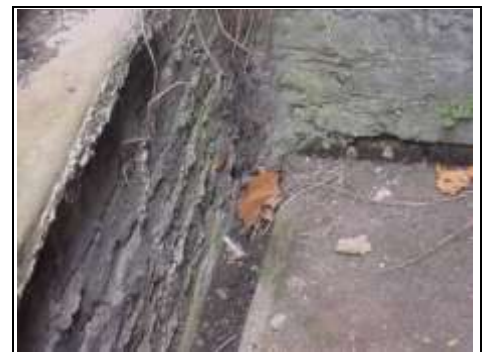
Gully around rear of the property that needs clearing

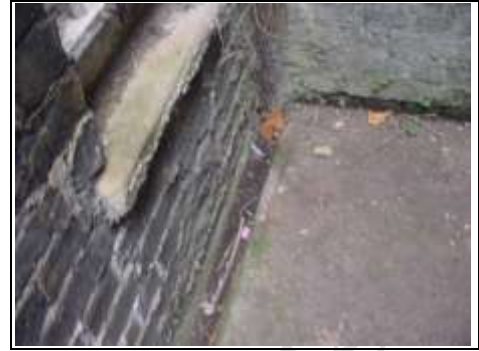
Brickwork frequently damp

There has been some deterioration where there has been water damage over the years.

**ACTION REQUIRED:** You need to repair your roof, gutters and drains to resolve the dampness problem.

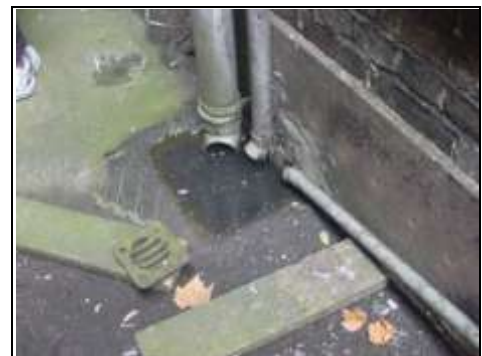
There is a render plinth to the base of the property indicating that it is likely to have a slate damp proof course behind it however it simply cannot cope with the amount of water that we can see to the rear of this property.

Render plinth to the base

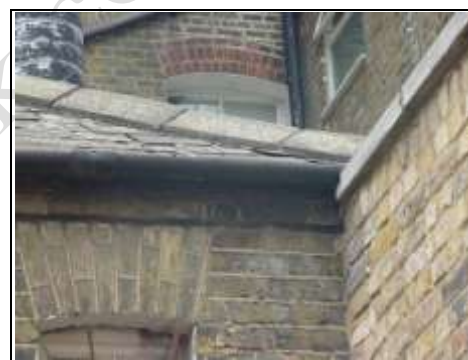
Fascias and soffits at low level

**ACTION REQUIRED:** Once the roofs and gutters are repaired then the fascias and soffits need repairing and redecoration.

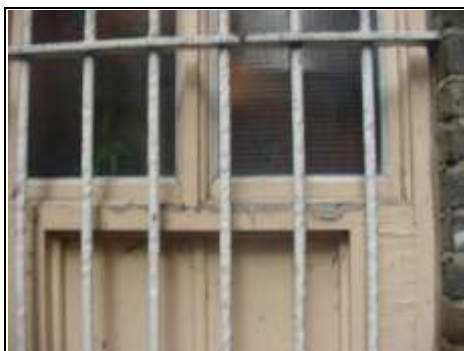
Flaky paint to window likely to require repair

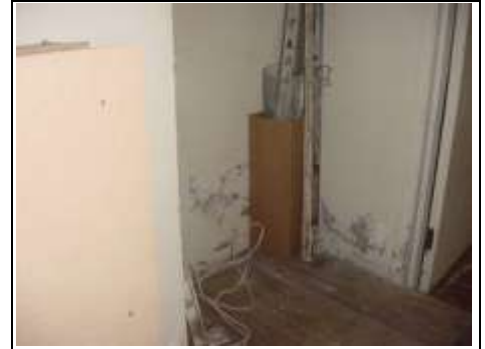
A random visual inspection and tests with a moisture meter have been taken to the perimeter walls and some internal walls. In this particular case we have found rising damp and we would comment as follows that there is a lot of dampness in the property which is both rising and lateral.

Rising damp

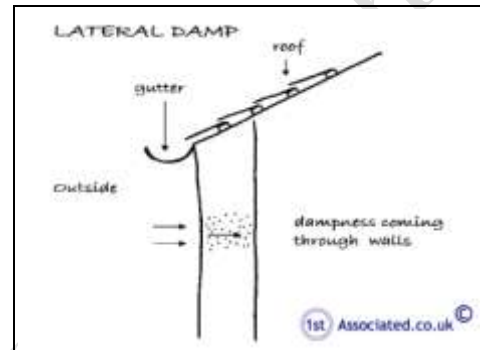
Lateral damp

**ACTION REQUIRED:** Please see our comments in the Executive Summary.

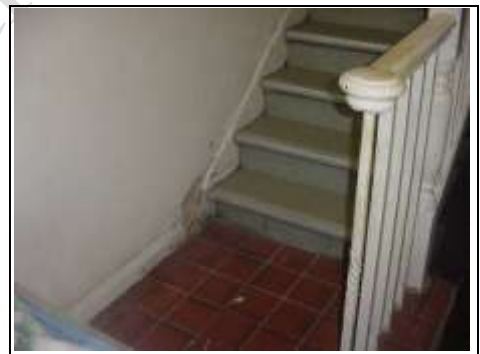
Dampness in the property
