SCHEDULE OF CONDITION

XXX
Cardiff
CF24 XXX

We have been instructed to inspect and prepare a Schedule of Condition for XXX Cardiff. CF24 XXX We inspected the property on XXX

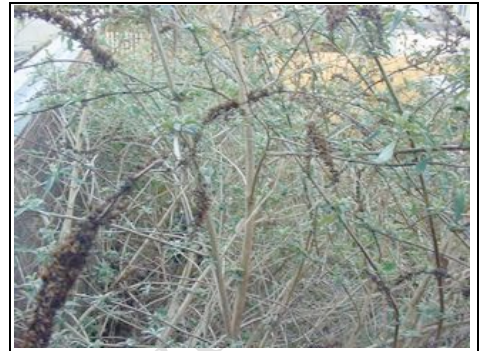
Rear garden

Condition: Overgrown

Action Required: Cut back trees and vegetation. Ensure safe access.

Re-visit required.

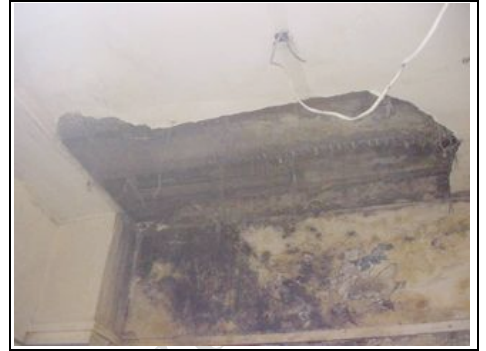
Dampness

Dilapidated
Areas of missing ceiling
Dampness coming into left side

Resolve water leak
Repair existing ceiling or
add suspended ceiling
system throughout

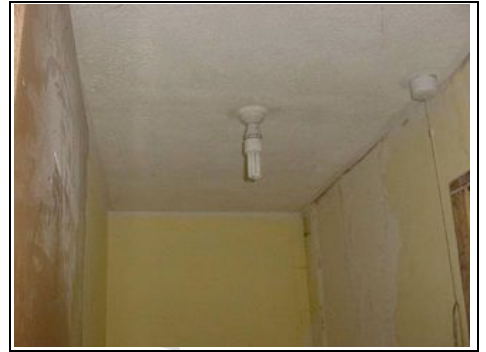
Ceiling

Condition: Dated

Action Required: Repair, prepare and redecorate

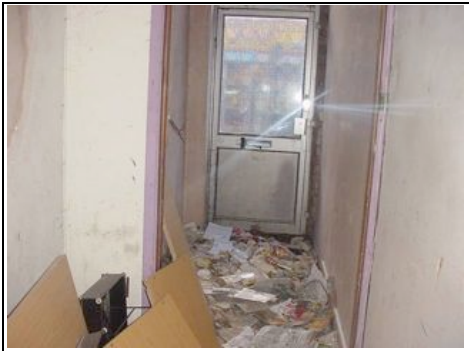
Hallway

The area was full of waste material which requires removal and limited our view at the time of our inspection.

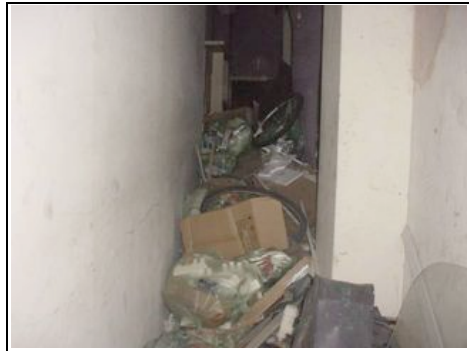
Rubbish in hallway/stairs

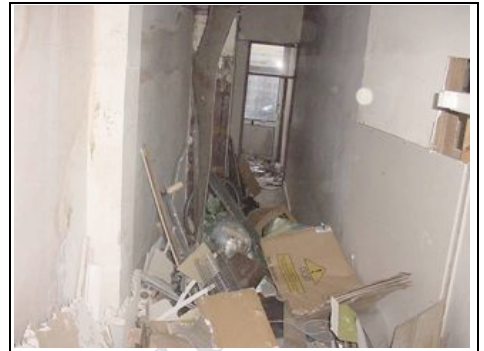
Hallway with debris

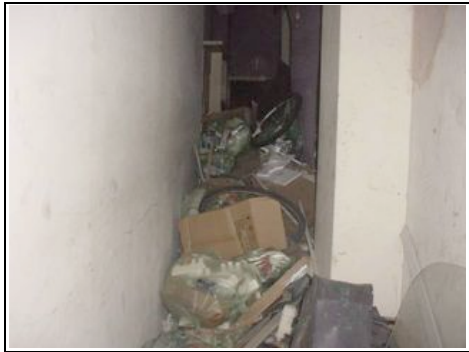
Rubbish in hallway/stairs

Condition: Limited view. See
Limitations section.

Area covered with stored
items and rubbish.

Action Required: Repair/replace

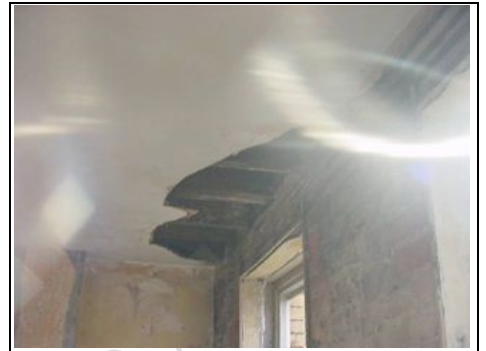
Front room

Condition: Water damage front right
Generally dilapidated

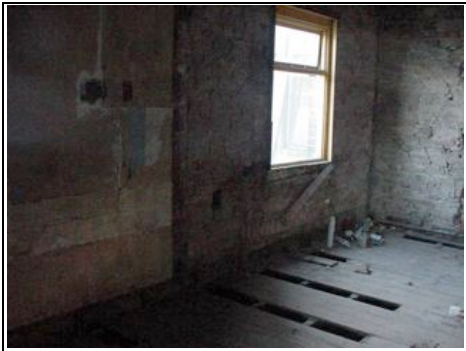
Rear room

Water damage left
Generally dilapidated

Make roof watertight
Add ceiling and associated insulation
We would also recommend re-roofing and adding ventilation
Any fire damaged timbers to be checked and repaired/replaced. Damage looks minimal, closer inspection may reveal more.

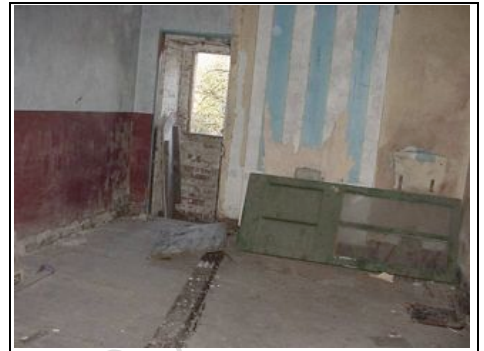
Rear wall

Dilapidated
Vertical crack right approx 1m
New lintel required

Action Required: Remove and replace existing lintel carrying out associated re-plastering and redecorating.

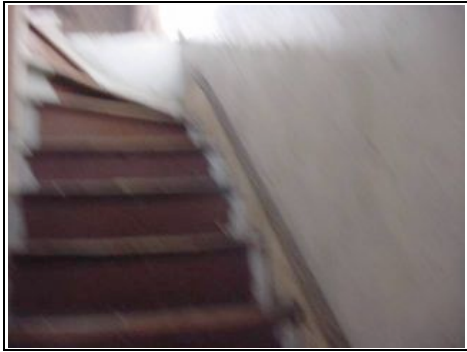
Stairs

Condition: Nosings deteriorated
No handrails
No newel posts

Action Required: Repair, prepare and redecorate
Add handrails and newel posts
Underclad with fire protective layer

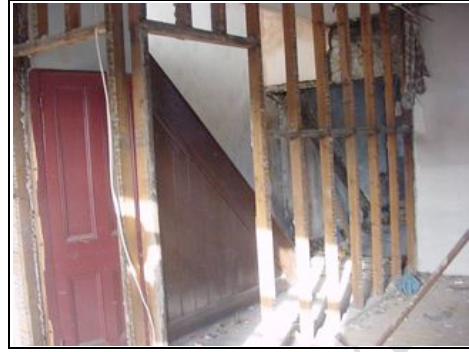
Studwork around staircase

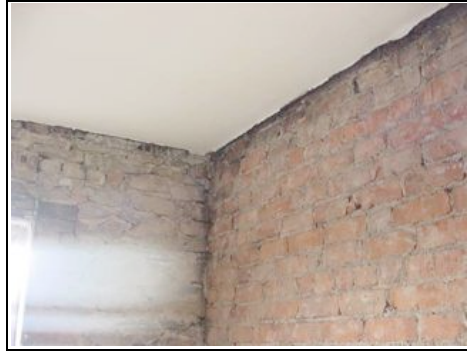
Looking at left side Party Wall

Condition: Cracking to chimney breast
We believe this may relate to dampness in the right side gable wall, it may also relate to movement for example from the drains which requires further investigation.

Action Required: Repair, prepare and redecorate

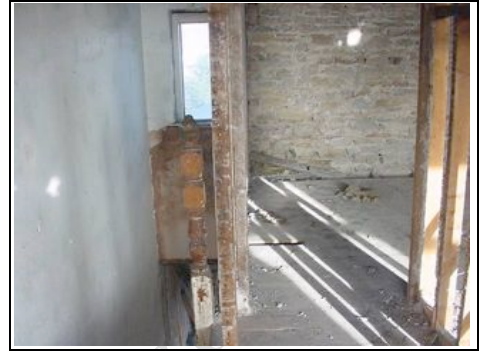
Rear room

Cracking to rear
Missing skirtings

Investigate crack. Plaster.
Add skirtings
