SCHEDULE OF CONDITION

XXXX

City of London,
EC3V XXX

We have been instructed to inspect and prepare a Schedule of Condition for XXXX, City of London EC3V XXX. We inspected the property on XXXX

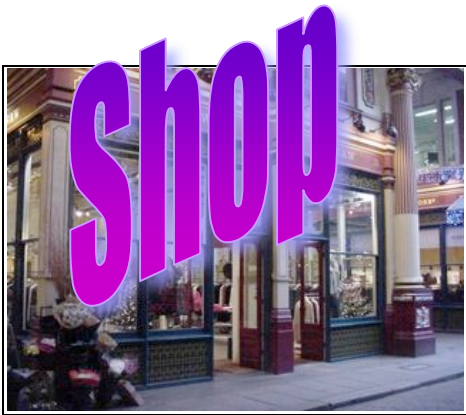
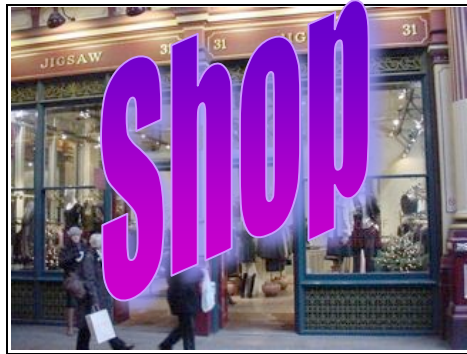
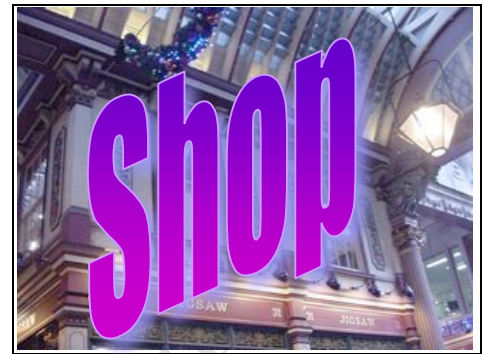
DESCRIPTION	CONDITION	ACTION REQUIRED
Roofs: 	Roof not visible but noted leaks within roof space.	Joint high level inspection with the landlord or landlord's surveyor to be carried out prior to signing of the lease or legal completion of the lease.
Box Gutters and Downpipes: Cast Iron	Not visible.	Joint inspection as above
Walls: Cast iron with infill cladding panels.

Rusting at basement/ground floor level. Deterioration to coving	Repair, prepare and redecorate.

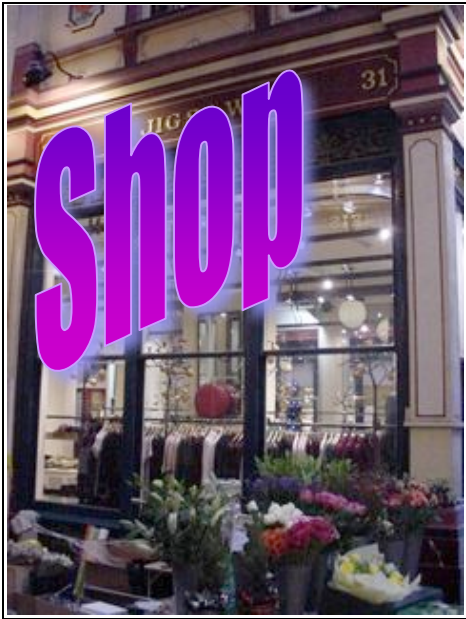
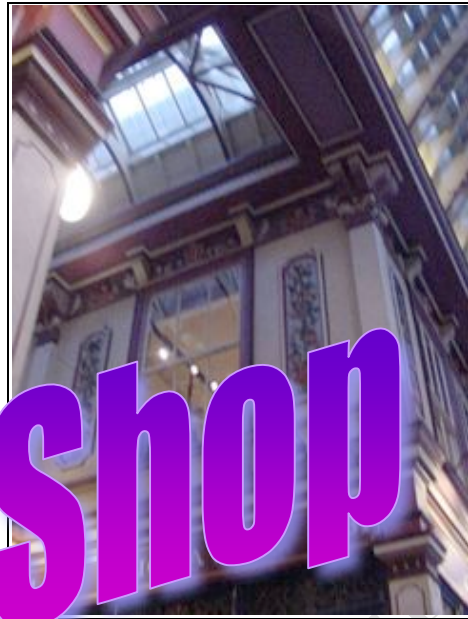
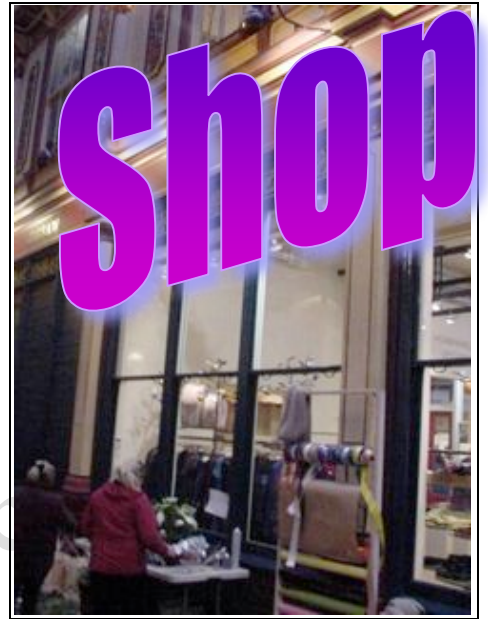
DESCRIPTION	CONDITION	ACTION REQUIRED
Roofs:	Not visible	Joint inspection; see front elevation.
Box Gutters and Downpipes: Lead and Cast Iron	Not visible	Joint inspection; see front elevation.
Stone fascia: High level limited view

Confirmation is required that the stone fascias does not form part of the Lease or repair liability associated with this.

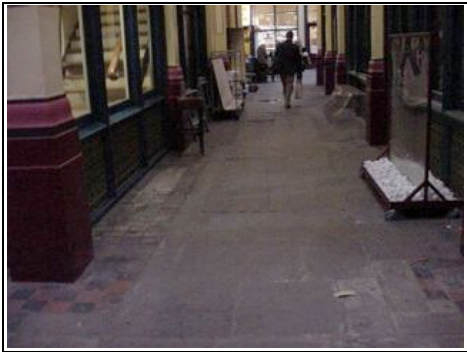
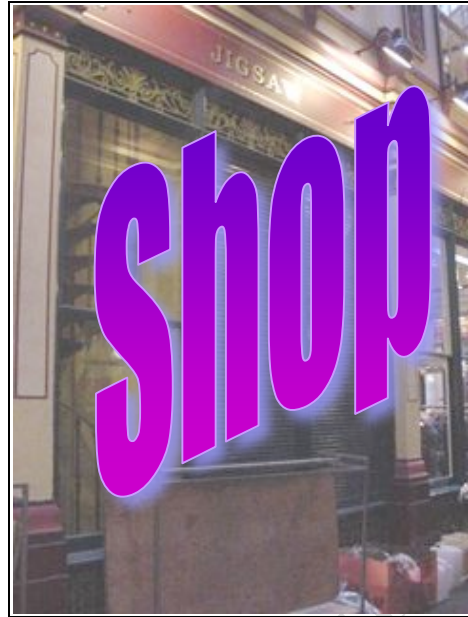
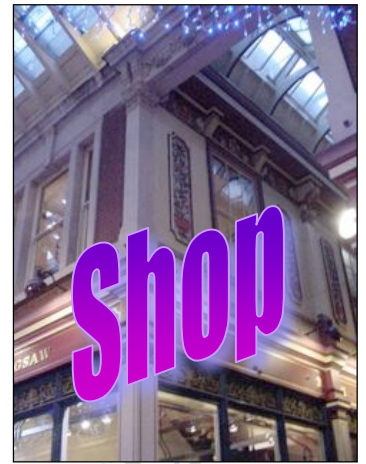
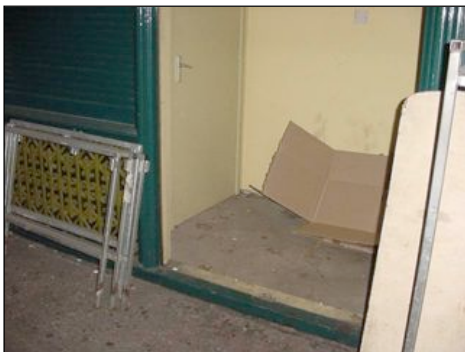
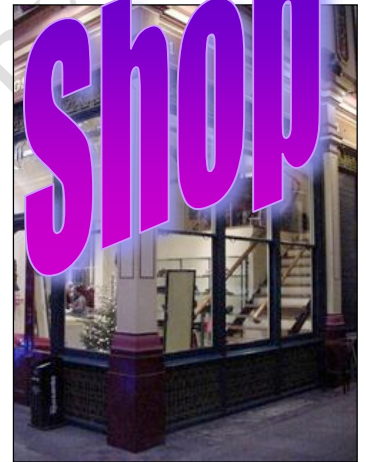
<p>Underside of box gutter</p>	<p>Not visible</p>	<p>Joint inspection; see front elevation.</p>
<p>Walls:</p> <p>Cast iron with infill cladding panels.</p>	<p>Rusting at basement/ground floor level.</p> <p>Dated</p> <p>Deterioration to coving</p>	<p>Repair, prepare and redecorate.</p>
<p>Columns:</p>

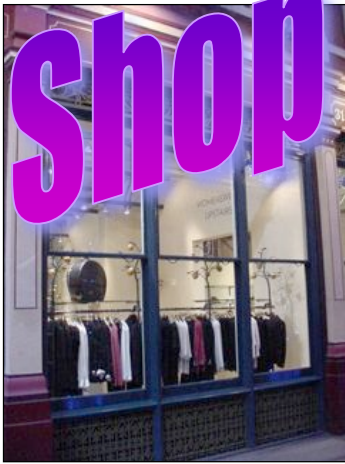
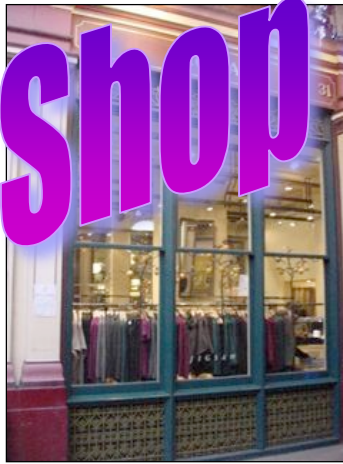
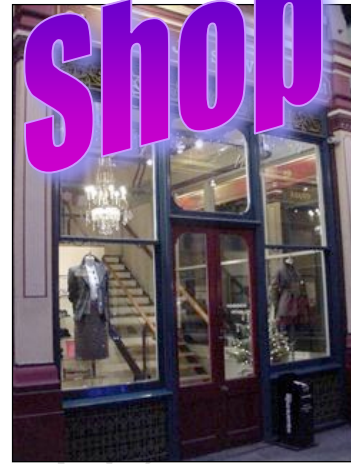
Deterioration at high level and leaking box gutter Deterioration to coving Rusting at ground floor level.	Repair, prepare and redecorate.

<p>Columns:</p>	<p>Heavily marked</p>   <p>Front right side</p>	<p>Confirmation is required whether the columns are included in the Lease.</p> <p>Repair, prepare and redecorate.</p>
<p>Decorative frieze: High level Limited view</p>

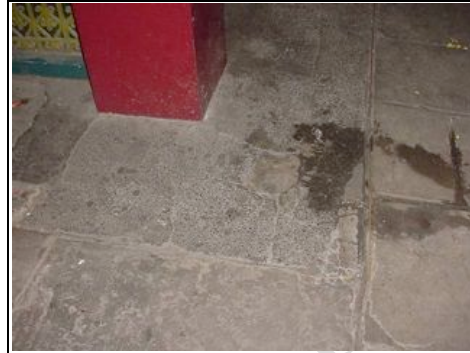
DESCRIPTION	CONDITION	ACTION REQUIRED
Area around property	Rear left corner heavily marked, stained and undulating.	Re-surfacing

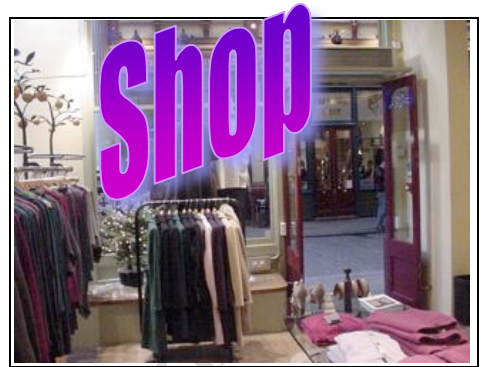
Front right trading area

<p>Walls: Predominately shop front windows. Painted above windows and to corners</p> <p>Timber top display areas with painted sides</p>	<p>Repair work not completed to front right hand side</p>

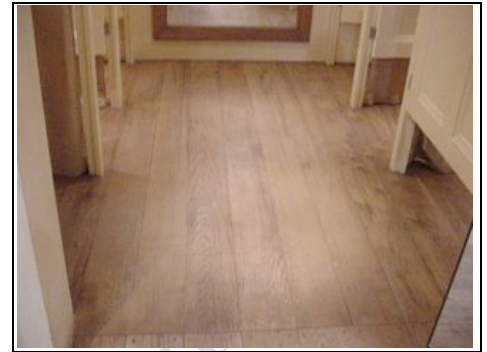
Floor

<p>Changing room floor</p>	<p>Sand, fill, repair, prepare and re-stain.</p>
<p>Detailing:</p> <p>Windows: Painted green</p>	<p>Dated</p>	<p>Repair, prepare and redecorate</p>

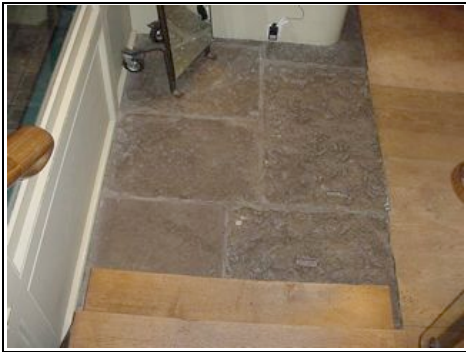
Rustic floor

<p>Floors:</p> <p>Rustic stone slab</p> <p>Floorboards run front to back</p> <p>Matt wells in front of doors</p>

<p>Marked by foot traffic</p>	<p>Deep clean</p> <p>Sand, fill, repair, prepare and re-stain.</p>
<p>Detailing:</p> <p>Windows</p>

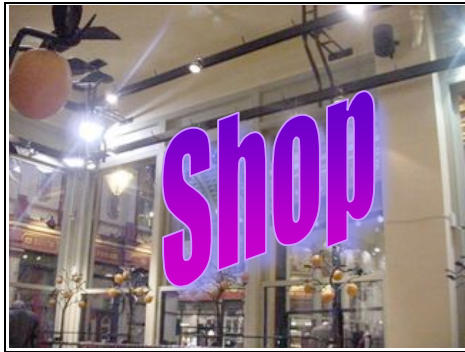
Front right

<p>Areas of repair to right side front corner that have not been decorated</p> <p>Dated</p>	<p>Repair, prepare and redecorate.</p>

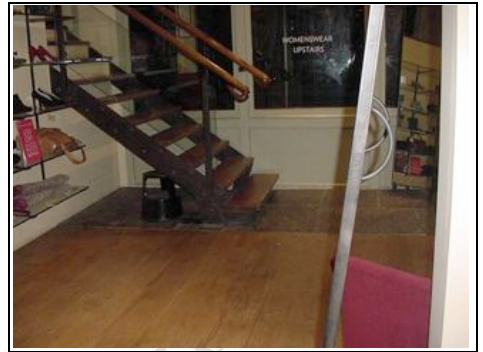
Customer's stairs to first floor

<p>Timber floor and rustic stone slabs and marked staircase</p>	<p>Sand, fill, repair, prepared and re-sand</p> <p>Clean and/or replace</p>
<p>Detailing:</p> <p>Windows: Painted</p> <p>Doors:</p> <p>Staircase to first floor:</p> <p>Wood</p>	<p>Dated</p> <p>Worn areas of steps</p>	<p>Repair, prepare and redecorate.</p> <p>Sand and re-stain and/or replace</p>
<p>Spiral staircase Fire Exit:</p> <p>Metal</p>

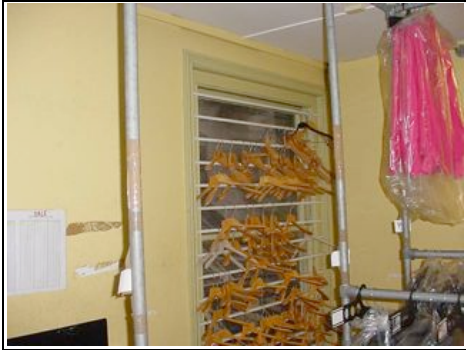
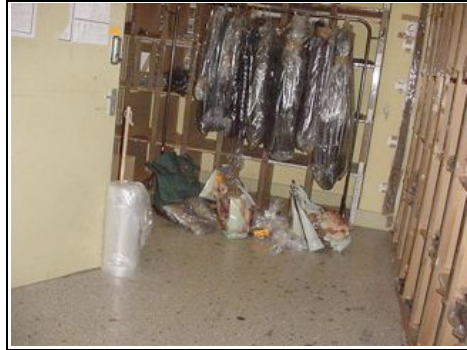
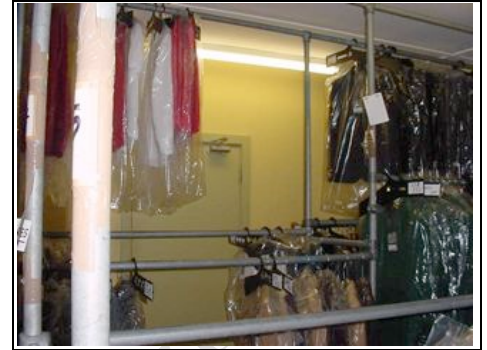
DESCRIPTION	CONDITION	ACTION REQUIRED
<p>Ceilings:</p> <p>Painted boarded</p>	<p>Dated. Repairs where water may have come in.</p>

<p>Walls:</p> <p>Painted yellow</p>	<p>Heavily marked and dented, particularly next to plant cupboard</p>   <p>Heavily marked wall</p> <p>Hairline cracking</p>	<p>Repair, prepare and redecorate</p> <p>Repair, prepare and redecorate</p>
<p>Floors:</p> <p>Vinyl</p>	<p>Dated</p>	<p>Clean and/or replace</p>
<p>Detailing:</p> <p>Sliding sash green windows:</p> <p>Doors:</p>  	<p>Screwed shut</p> <p>Dated, heavily marked.</p>	<p>Repair, prepare and redecorate</p> <p>Repair, prepare and redecorate</p>

<p>Resolve dampness. Repair, prepare and redecorate</p>

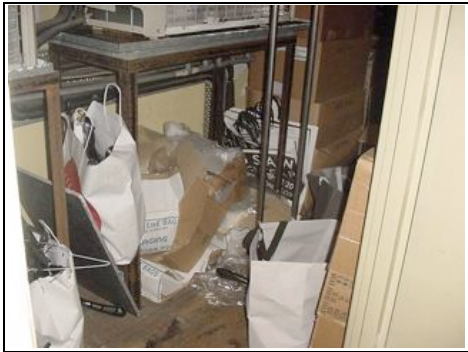
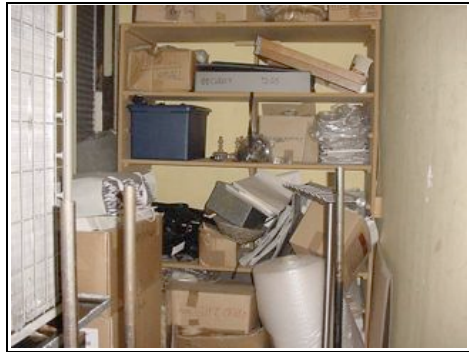
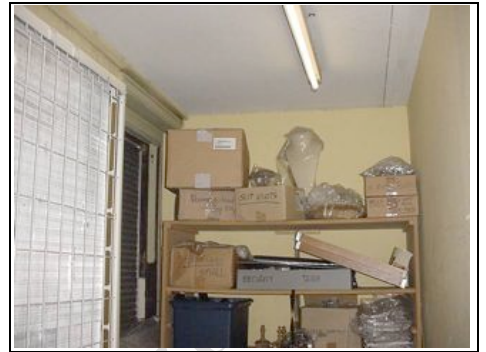
<p>Dated and marked</p>	<p>Repair, prepare and redecorate</p>

<p>Walls:</p> <p>Painted</p>	<p>Dated Hairline cracking to right hand side and dampness coming through</p>

<p>Hairline cracking and dampness coming through</p>

<p>Dampness</p>	<p>Resolve dampness. Repair, prepare and redecorate</p>
<p>Floors:</p> <p>Wood boarded with joists running front to back</p>	<p>Signs of dampness Rusting to unit that holds the three air conditioning modules in place</p>	<p>Sand, fill, repair, prepare and re-stain.</p>
<p>Detailing:</p> <p>Four grilled windows</p> <p>Doors:</p>	<p>Dated</p> <p>Dated</p>	<p>Repair, prepare and redecorate</p> <p>Repair, prepare and redecorate</p>

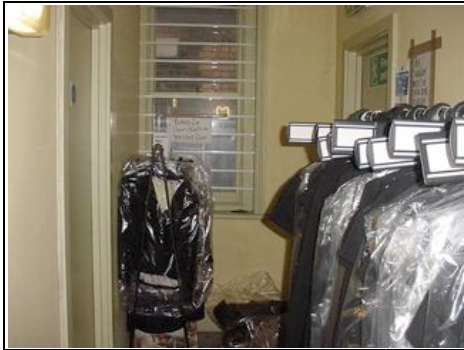
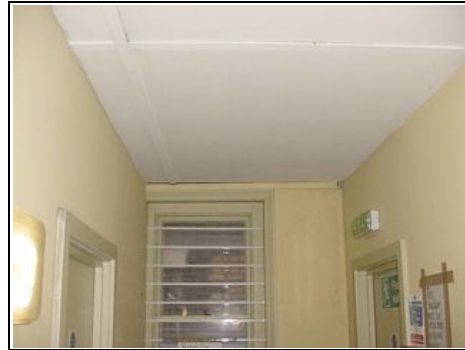
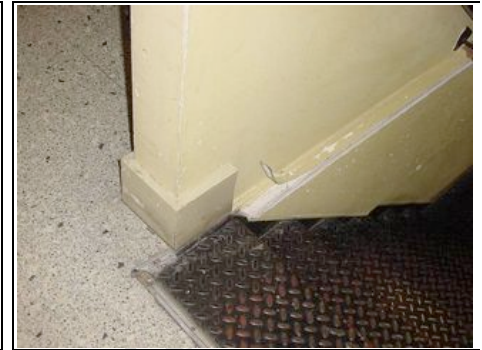
DESCRIPTION	CONDITION	ACTION REQUIRED
<p>Ceilings:</p> <p>Painted</p> <p>Access hatch</p>	Dated	Repair, prepare and redecorate
<p>Walls:</p> <p>Painted</p>	<p>Heavily marked and indented</p>

Repair, prepare and redecorate
<p>Floors:</p> <p>Vinyl</p>	Dated	Clean and/or replace
<p>Detailing:</p> <p>Double doors to store room</p>	Marked	Repair, prepare and redecorate

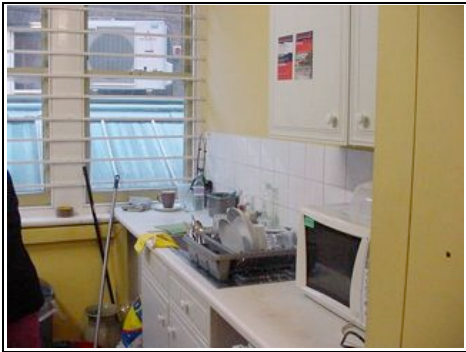
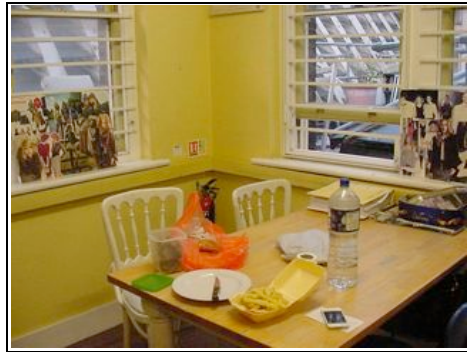
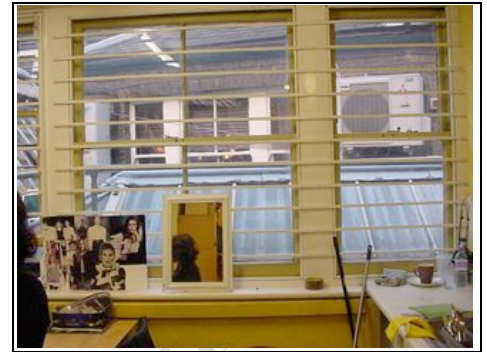
DESCRIPTION	CONDITION	ACTION REQUIRED
<p>Ceilings:</p> <p>Painted</p>	<p>Board missing Signs of dampness Patch repairs to corner</p>

<p style="text-align: center;">Ceiling</p>	<p>Resolve dampness.</p> <p>Repair, prepare and redecorate</p>
<p>Three fluorescent lights</p>	<p>No diffusers</p>	<p>Add diffusers</p>

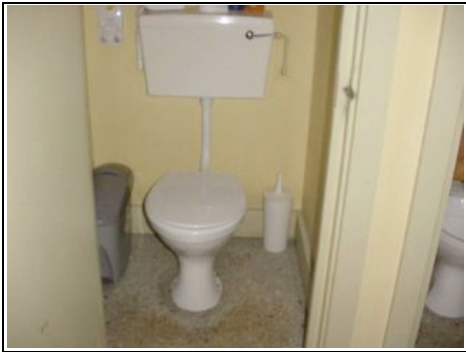
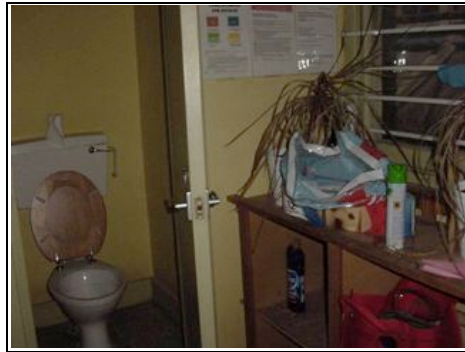
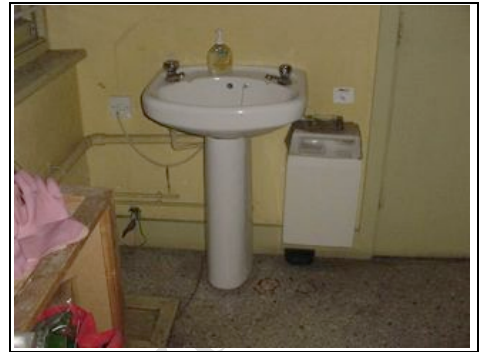
DESCRIPTION	CONDITION	ACTION REQUIRED
Ceilings: Painted	Dated and impact damage Cracking to ceiling level	Repair, prepare and redecorate
Walls: Painted plaster Studwork internal wall	Dated Vertical cracking to the studwork internal wall	Repair, prepare and redecorate Repair, prepare and redecorate
Floors: Vinyl	Worn	Clean and/or replace
Sanitary Ware: Two WC's, one wash hand basin	Dated	Deep clean

<p>Detailing:</p> <p>Sliding sash windows</p> <p>Doors:</p>	<p>Dated</p> <p>Dated</p>	<p>Repair, prepare and redecorate</p> <p>Repair, prepare and redecorate</p>
<p>Services:</p> <p>Water heater</p>

<p>Dated</p>	<p>Replace</p>

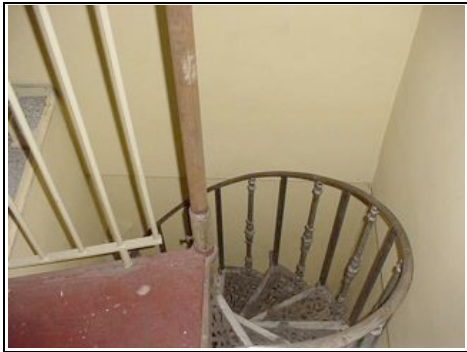
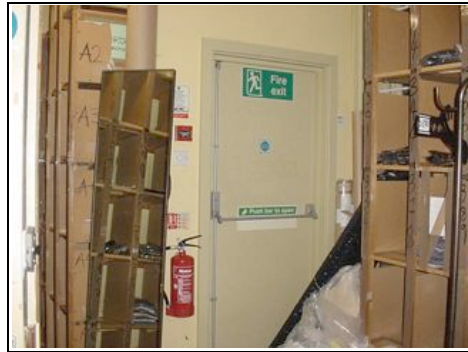
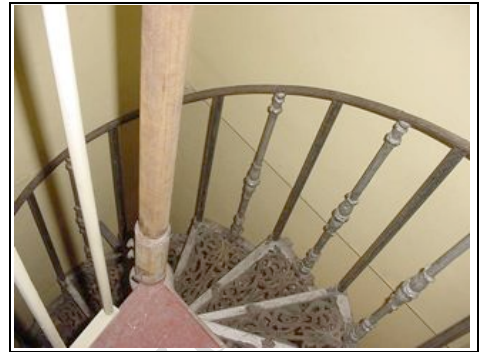
<p>Hairline cracking to corner Undulations, indicating water getting in</p>	<p>Repair, prepare and redecorate</p>
<p>Inner stud wall</p>	<p>Cracking around it</p>	<p>Repair, prepare and redecorate</p>

<p>Replace</p>
<p>Stairs:</p> <p>Spiral metal staircase (not accessed)</p>	<p>Dated</p>	<p>Repair, redecorate, prepare and</p>
<p>Detailing:</p> <p>Sliding sash green windows:</p>

<p>Screwed shut to could not check to see if they were operational Painting missed directly above windows Set of pulley cords missing</p> <p>No internal ironmongery (we assume for security purposes)</p>	<p>Repair, redecorate, prepare and</p> <p>Repair, redecorate, prepare and</p>
