COMMERCIAL BUILDING SURVEY

Morden

Surrey. SM4 XXX

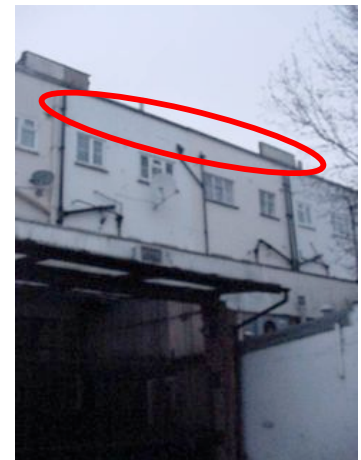
Rear main roof with parapet wall

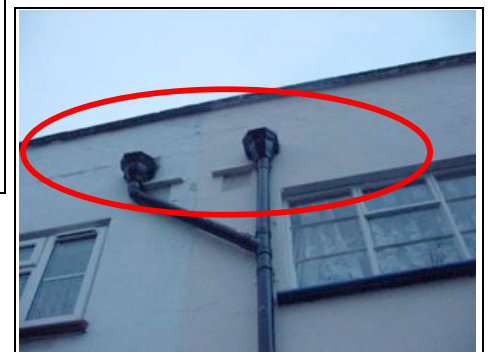
Hopperheads and parapet wall

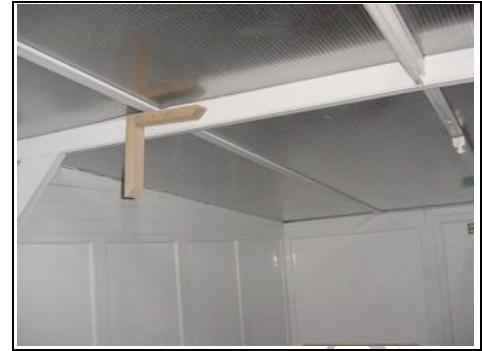
Polycarbonate roof internal view

The large tree via falling branches etc cause impact damage. We noted a fairly large quantity of leaves on the shallow polycarbonate roof at the time of our inspection which do need to be cleaned away regularly to stop the roof from deflecting and letting in rainwater/failing.

ACTION REQUIRED: Clean roof.

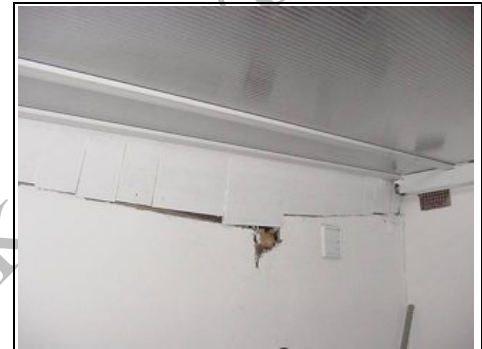
Poor infilling on conservatory

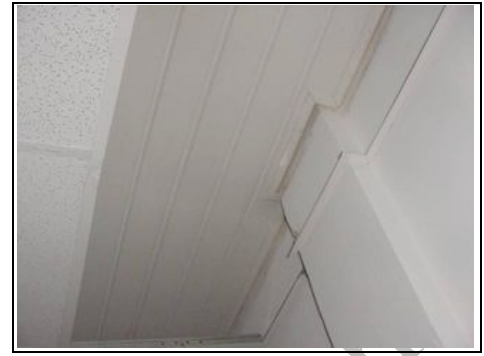
Cladding behind suspended ceiling in office

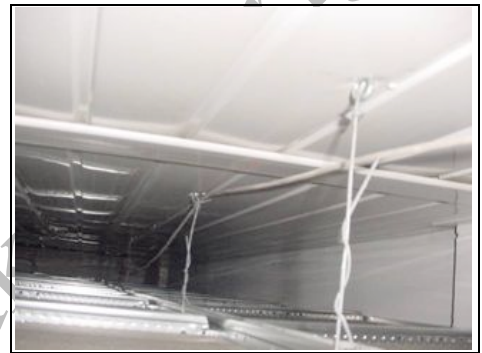
Plastic cladding above suspended ceiling

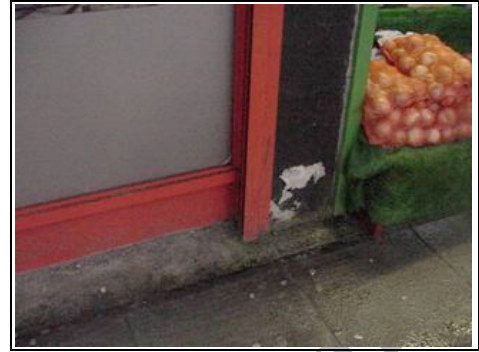
Plaster/column needs decorating

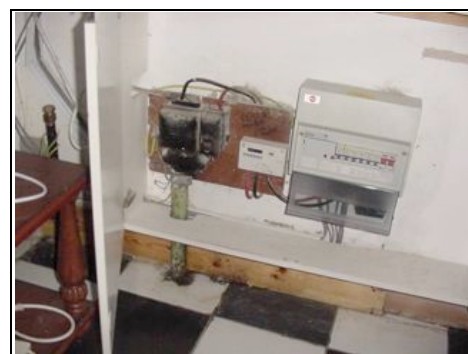
The 1980s/1990s electrics are located in the office. We would normally carry out a basic test in the kitchen area however in this case there were no socket points in the kitchen (around the kitchen units area) which in itself is a concern.

Electric fuseboard in office

We have a concern regarding the quality of the electrics in this property.

The Institute of Electrical Engineers standards (IEE) recommend a test and report whenever a property changes occupancy. This should be carried out by an NICEIC registered and approved electrical contractor or equivalent.

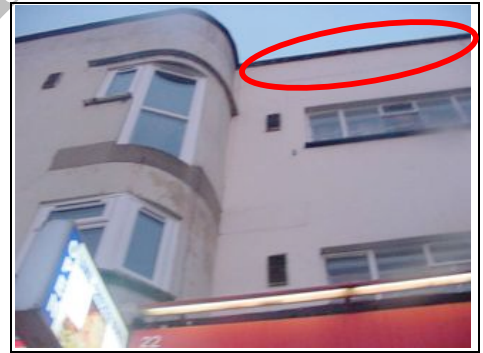
We have been unable to view the main roof due to the parapet wall that hides it both at the front and the rear of the property.

We typically find where we have seen this roof that it is a flat roof that is asphalt covered on a timber or concrete decking. We believe this roof is most likely to be on a timber decking in this instance.

Hidden main roof

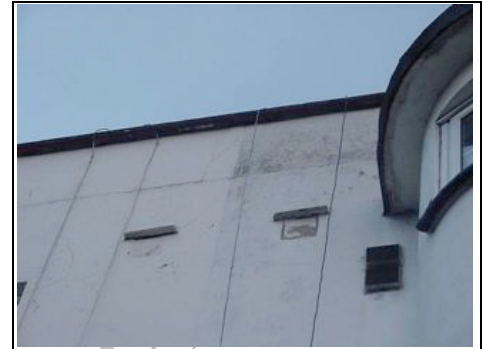
Hidden parapet wall

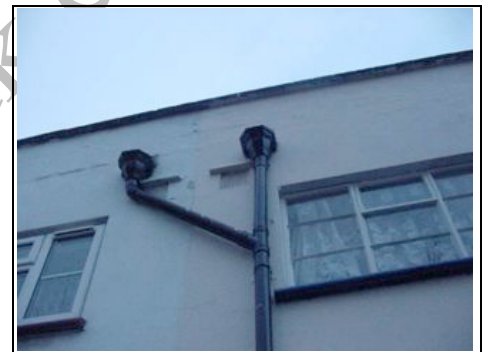
Box gutter and parapet wall to the rear of the property

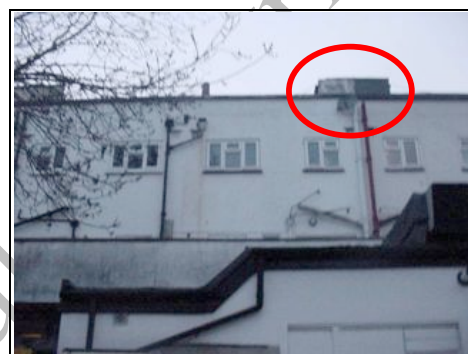
We could see to the roof at the rear higher areas which may be communal tanks which were not uncommon in this era of property particularly in residential areas.

Rear of property high level area

We would always recommend that water tanks be drained down and cleared of any debris etc. (we have seen dead birds and other unmentionable things in these tanks).

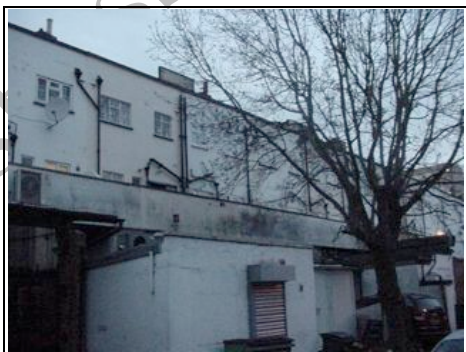
Render to walkway repainted

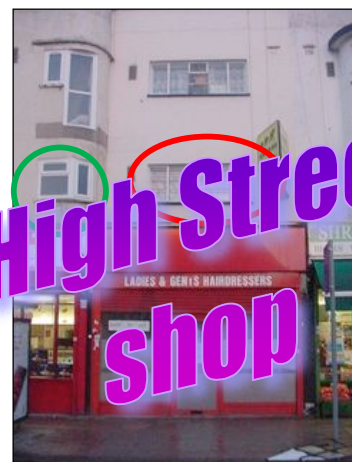
Front windows to residential area
Plastic or timber (green circle)

Metal (red circle) 46

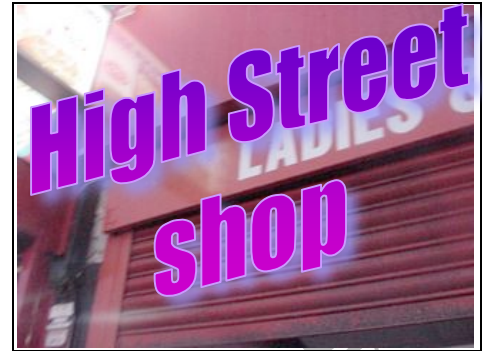
We have not tested the roller shutter doors at the front of the property which at the time of our survey were in the up position.

Roller shutter doors

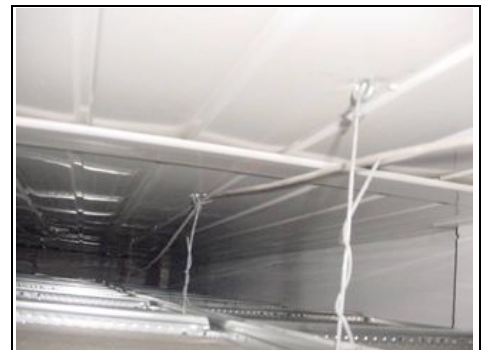
Plastic cladding above suspended ceiling

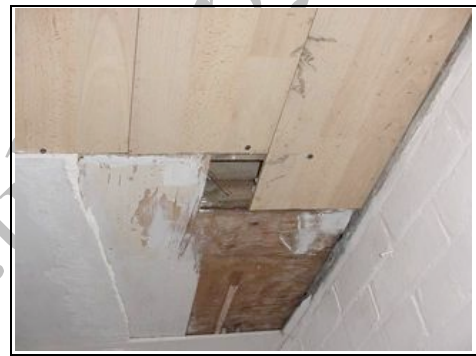
There are holes in the toilet area which require repair and redecoration.

Hole in ceiling in toilet
