# PROPERTY REPORT

**XXXX**  
**Islington,**  
**London. N1 XXX**

We have been instructed to inspect and prepare a Report and Schedule of Condition for XXX Islington, London. N1 XXX

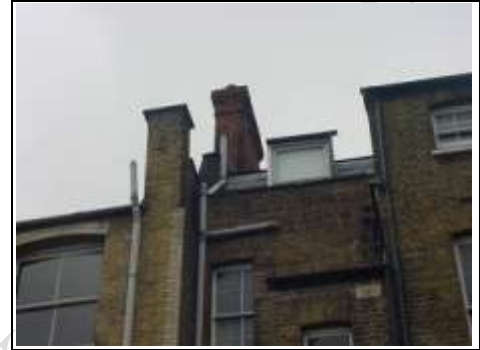
Viewing the property at high level

- 1.1) Chimneys – chimneys built in soft red brick and also large chimneys have been amended.
- 1.2) Roof – slate roof which we can see some tiles are missing and is poorly detailed.
- 1.3) Box gutter detail – renowned for blocking and causing dampness into the structure.

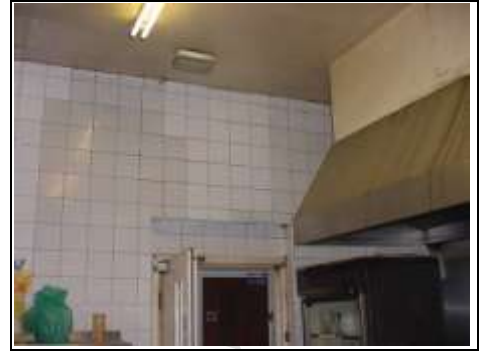
Kitchen

We feel that you need improved extraction in your kitchen and also in the toilet areas. The difficulty with the kitchen is that the smells may discharge towards the nursery, estate agent and any other premises at the rear. As you are aware, these neighbours have complained previously about the smells.

The extract system that is in place we cannot see any way of cleaning it via access points although we have not been able to gain close access to it.

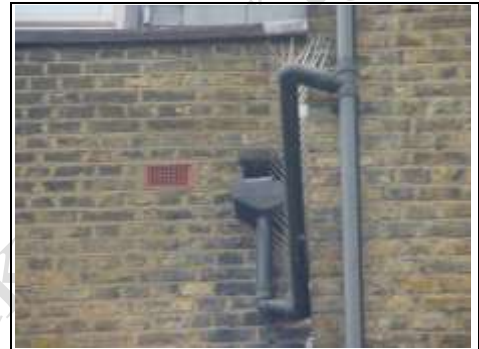
Pigeon defectors

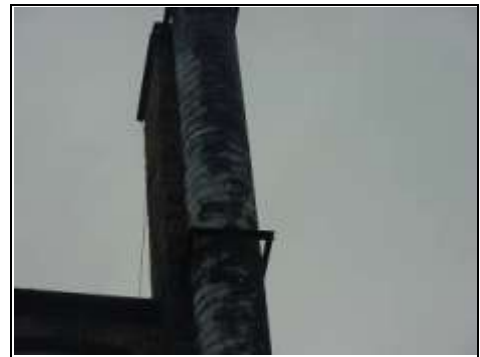
Chimney one

The main chimney that we can see we would like to comment on is to the rear and has the flue attached to it and is brick built but our main concern is how much of the base of the chimney has been altered.

**ACTION REQUIRED:** We were unable to gain access to this area, we do feel it needs excluding from the lease.

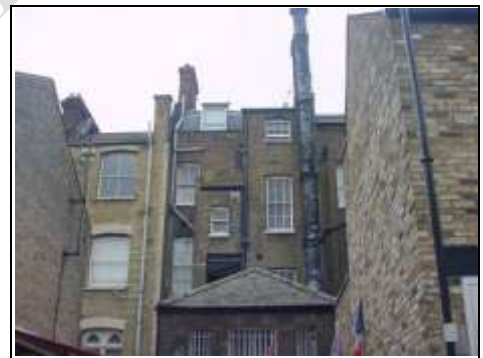
Main roof

The main roof is pitched and we assume clad with a slate although it is difficult to see from ground level. The property looks to have a mansard style roof, often these have problems with the box gutters. We can see in this case there is a box gutter with a small parapet wall.

**ACTION REQUIRED:** The roofs need inspecting properly. Your Legal Advisor needs to obtain a copy of the Planned Maintenance Schedule for the property as a whole.

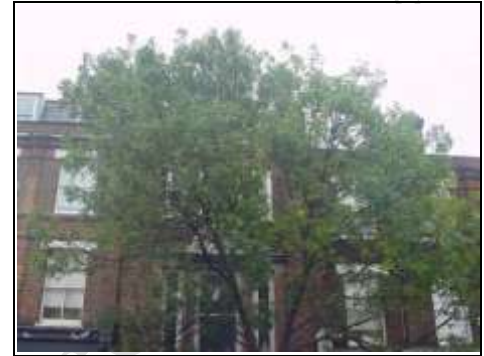
There is a tree within what we would term as influencing distance of the property.

The tree is located to the front of the property

**ACTION REQUIRED:** Your legal advisor to check and confirm who is responsible for maintenance of the tree.

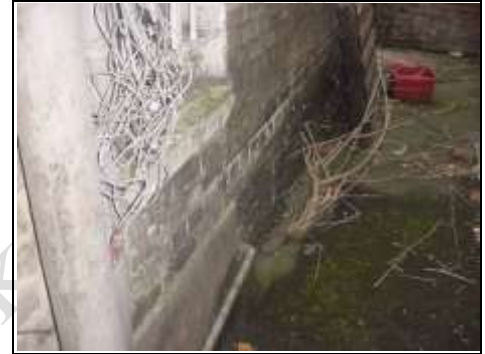
Render plinth

All modern properties should incorporate a damp proof course (DPC) and good building practice dictates that a differential of 150mm (6 inches) should be maintained between the damp proof course and ground levels. In this case, we were not able to see a damp proof course due to it being covered with a rendered plinth.

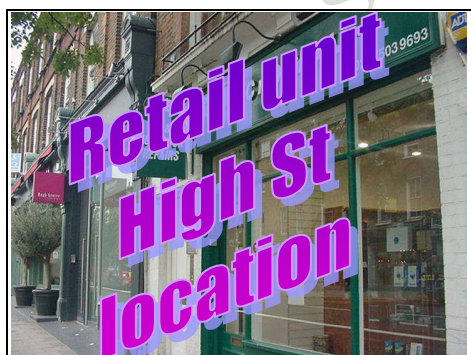
Picture window to the front in good condition

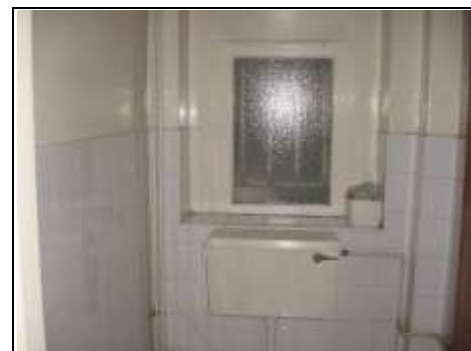
Unusual glazing on inside of the window. We have not seen this window from the outside but we

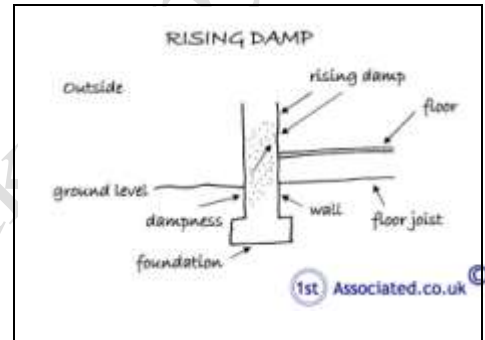
Rising damp

A random visual inspection and tests with a moisture meter have been taken to the perimeter walls and some internal walls. In this particular case we have found rising damp and we would comment as follows that there is a lot of dampness in the property which is both rising and lateral.
