SCHEDULE OF CONDITION

XXXX

City of London,
EC3V XXX

We have been instructed to inspect and prepare a Schedule of Condition for XXXX, City of London EC3V XXX. We inspected the property on XXXX

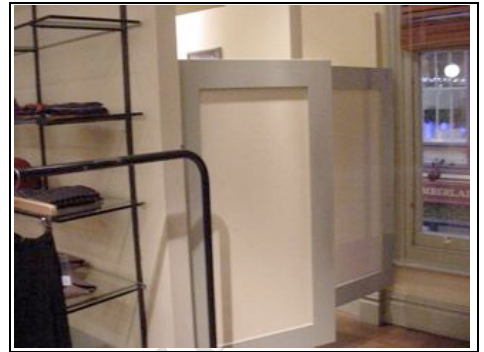
Four changing cubicles

DESCRIPTION	CONDITION	ACTION REQUIRED
<p>Ceilings:</p> <p>White painted ceiling</p>	Dated	Repair, prepare and redecorate
<p>Walls:</p> <p>Four changing cubicles Free standing painted studwork wall</p>	<p>Marked and pattern staining Damage to corners</p>

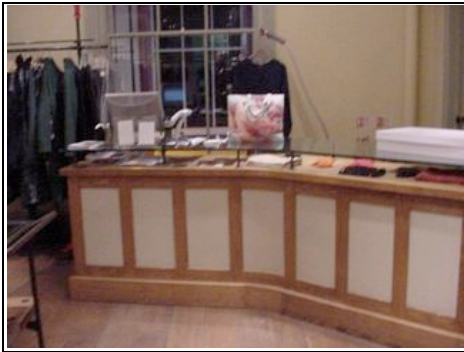
Counter

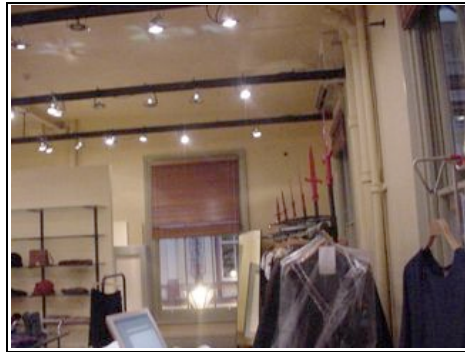
Left view

DESCRIPTION	CONDITION	ACTION REQUIRED
<p>Ceilings:</p> <p>Painted</p>	Dated	Repair, prepare and redecorate
<p>Walls:</p> <p>Painted</p> <p>Pay counter</p>	<p>Dated</p> <p>Assumed existing tenant's fixture and fitting and should be removed</p>	Repair, prepare and redecorate
<p>Floors:</p> <p>Wood</p>	Worn and marked	Sand, fill, repair, prepare and re-stain.

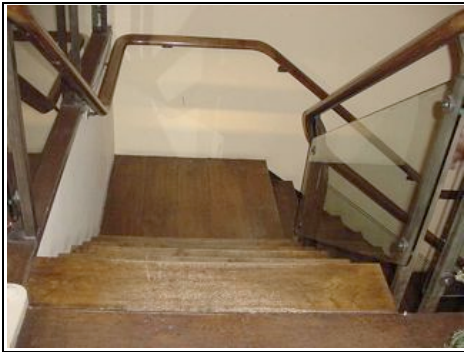
Customer Staircase

DESCRIPTION	CONDITION	ACTION REQUIRED
Ceilings: Painted	Dated	Repair, prepare and redecorate
Walls: Painted	Dated Heavily marked in staff staircase area	Repair, prepare and redecorate
Floors: Wood	Marked and worn by foot traffic Heavily marked in staff staircase area	Sand, fill, repair, prepare and re-stain.
Detailing: Window in shop area one partly hidden by staircase	Dated	Repair, prepare and redecorate

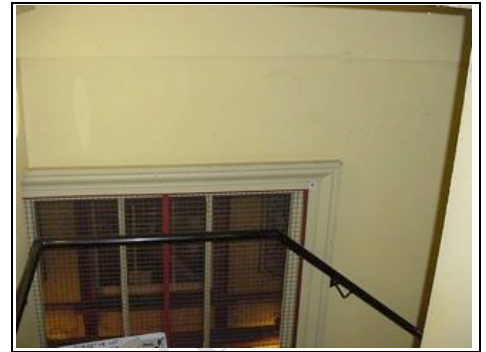
Window within staff staircase area
