COMMERCIAL BUILDING SURVEY

Morden

Surrey. SM4 XXX

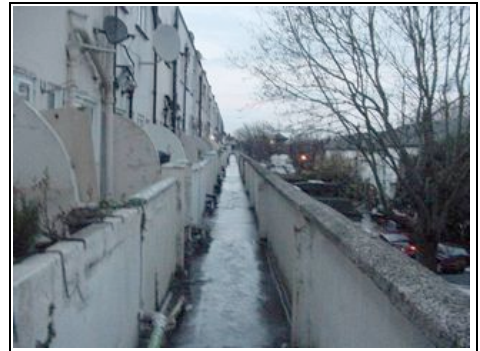
Rear walkway

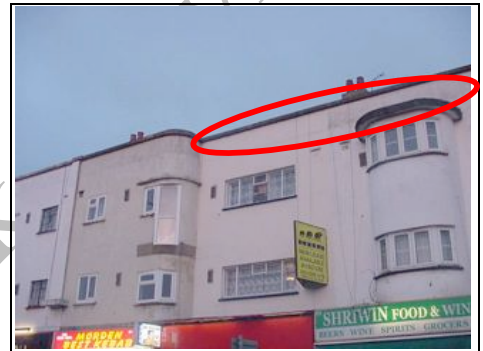
Parapet wall

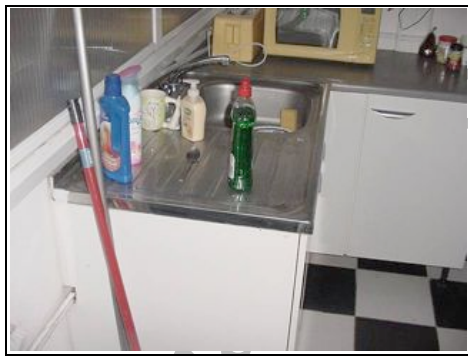
Kitchen unit

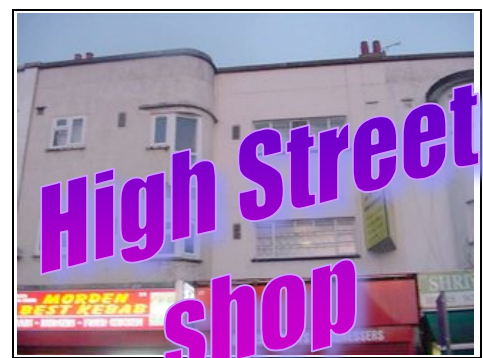
Painted render at front of property

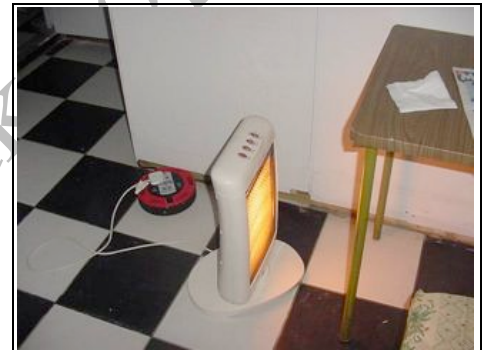
At the time of our inspection there was an electric heater in the rear store area. With the dampness in this property it certainly needs background heating.

Electric heater

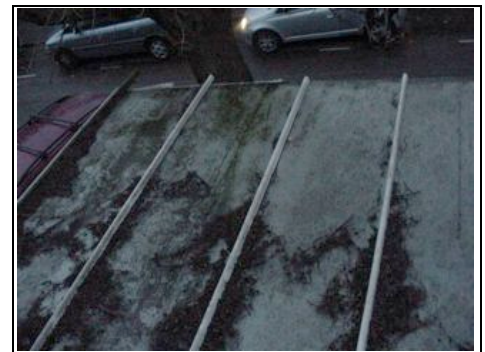
The conservatory area to the rear of the property has, in our opinion, a DIY standard polycarbonate roof.

Polycarbonate roof 33

ACTION REQUIRED: Please see our comments in the Executive Summary.

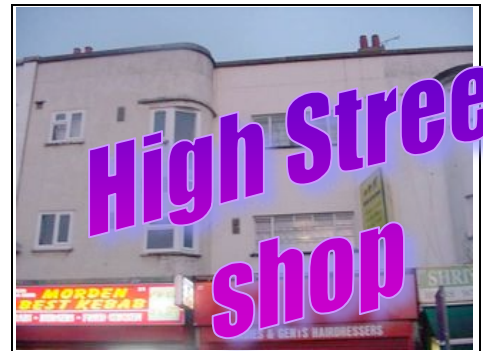
The primary cladding material is render which is painted.

Painted render

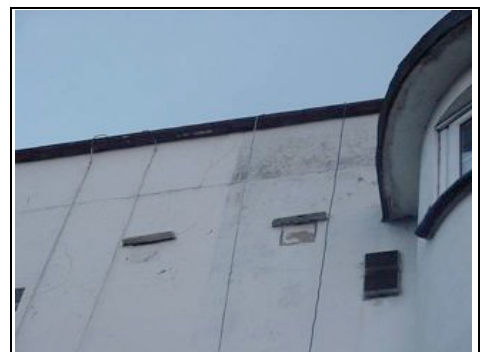
Render at high level and hidden parapet wall

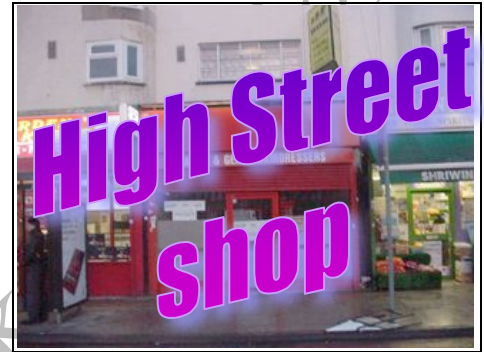
The shop front is metal frame with a proprietary painted applied coat finish which is in average condition for its age, type and style. We typically find that these fade in time.

Shop front

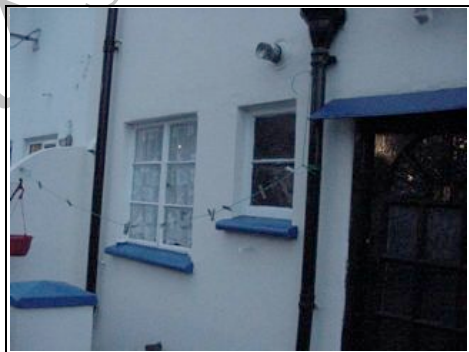
You may have a shared responsibility for residential area windows which are metal windows and single glazed to the front of the property and to the rear there may be some plastic or timber replacement windows in the communal areas.

Windows to residential area
